**GRAND VIEW**  
Property Services

## RESIDENTIAL INSPECTION

**August 25, 2026**

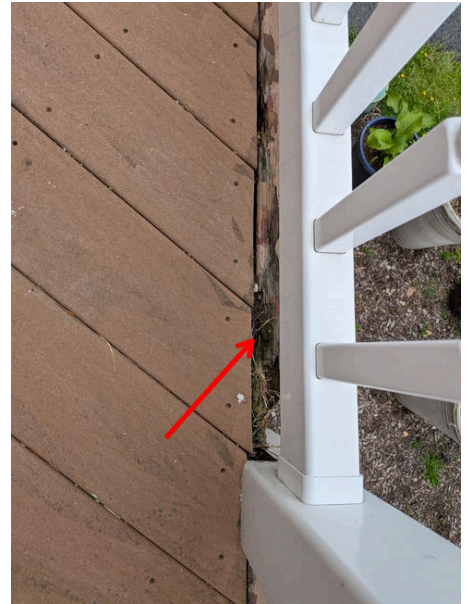
**Deck Beam - Damage**

Moisture and wood destroying organism damage was observed on the deck beam. Recommend further evaluation and replacement of damaged beam as needed.

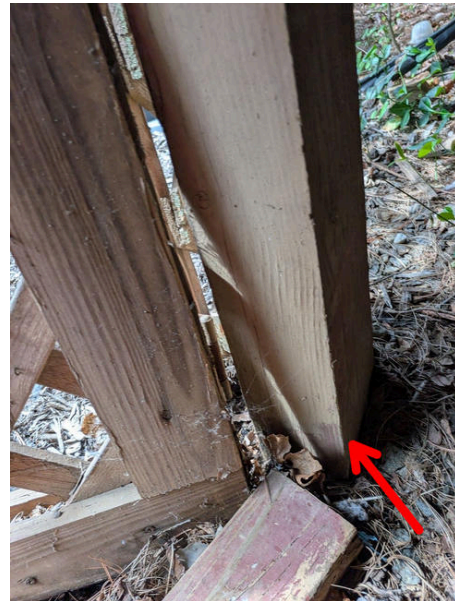
📍 DECK

Some of the deck posts were in contact with the ground or had moist dirt at the base. This will likely accelerate degradation due to potential moisture damage. Recommend ensuring debris is away from the post to limit damage over time. *All may not be shown.*

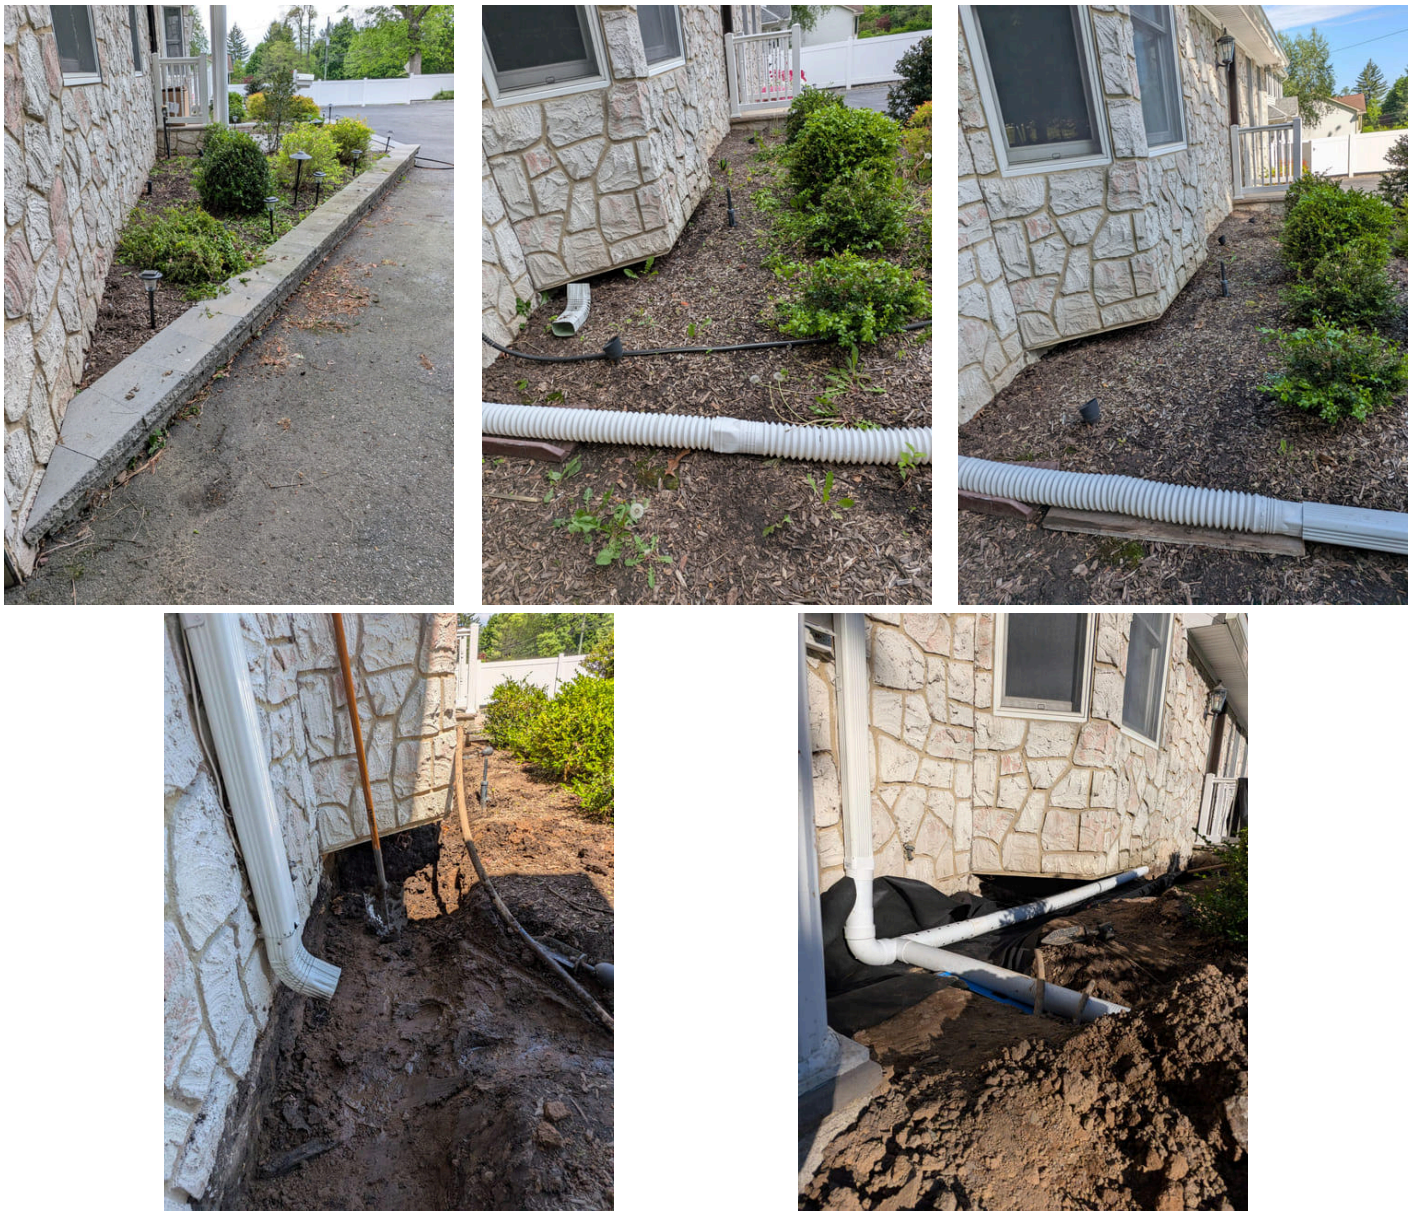
Some flower raised beds/Plant Box attached to the foundation and exterior wall. This prevent a visual inspection of the foundation wall and the lower portion of the exterior siding/trim behind the planter.

The soil in the raised bed is in direct contact with the home's siding/trim. This traps moisture against the wall, leading to wood rot and decay. **Action:** Remove soil/planter or ensure a waterproof membrane and air gap exist between the planter and the wall.

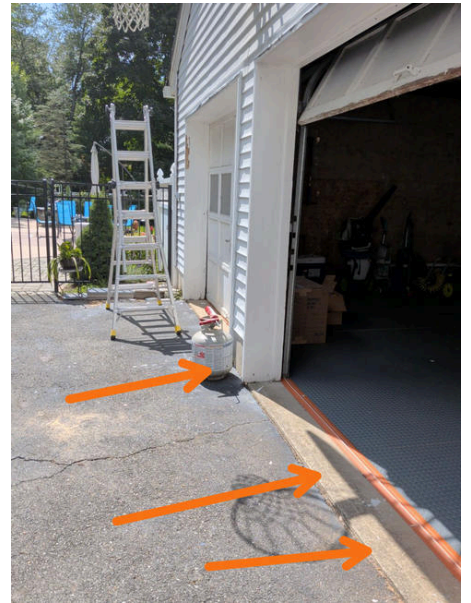
At the front of garage door, the grading transition between the driveway, the garage entrance slab, and the adjacent walk path is minimal, creating a low spot where surface water accumulates during heavy rain. Standing water was observed pooling at the foundation line and the garage floor indicating inadequate drainage away from the structure.

**Recommendation:** Install a French drain or re-grade the area to direct runoff away from the garage foundation, and consider adding swales or other drainage improvements.

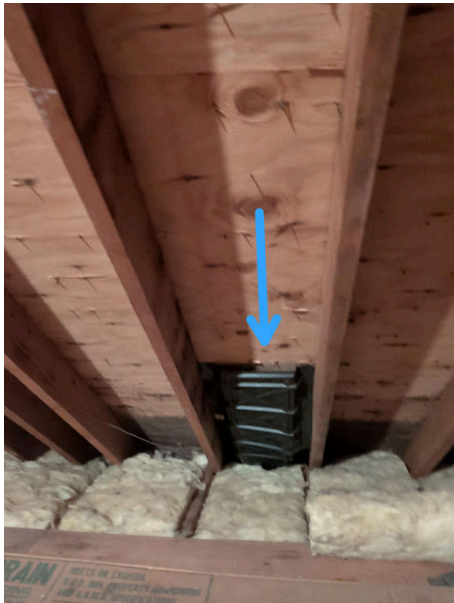
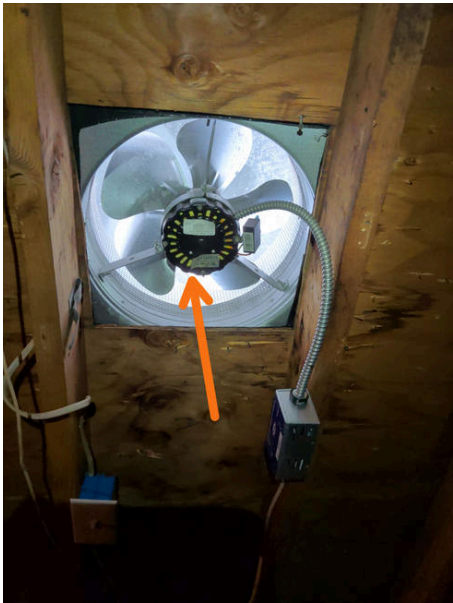
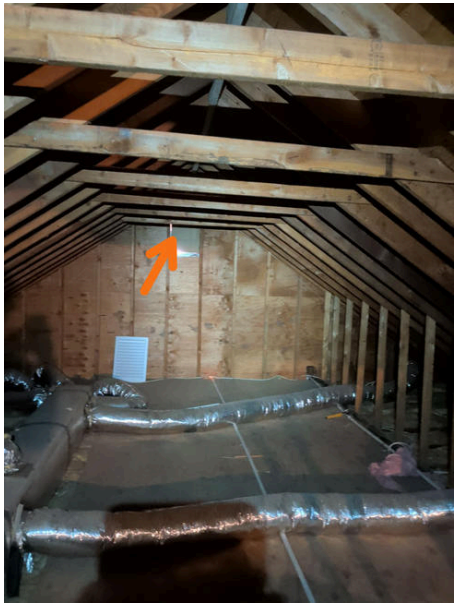
Using the four ventilation methods simultaneously creates an **airflow short-circuit**, which reduces overall ventilation effectiveness in the attic. The combined operation of the **turtle box** and **gable vent** with the **soffits** and **power fan** short-circuits the intended airflow path.

**Recommendation:** Close the **turtle box** and the **gable vent**, retaining only the **soffits** and **power fan** to restore proper ventilation.

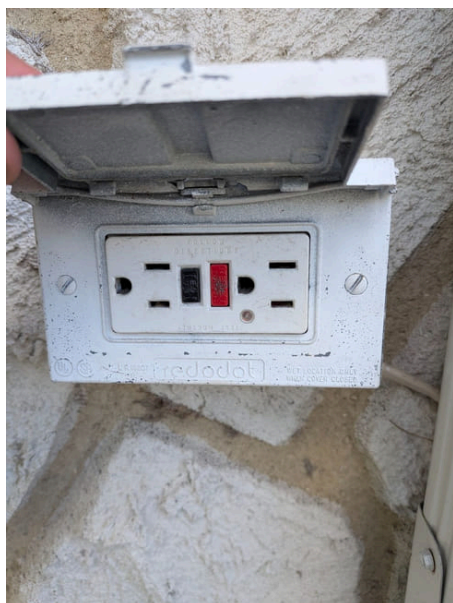
#### ✓ Cover missing

*Any outlet lacking a proper cover, or with a damaged cover, should be corrected to meet safety standards.*

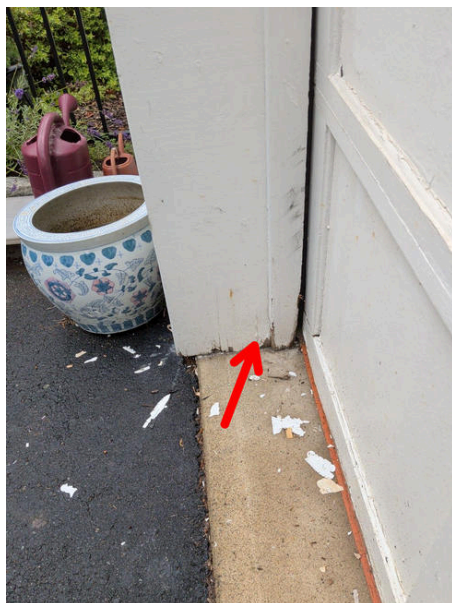
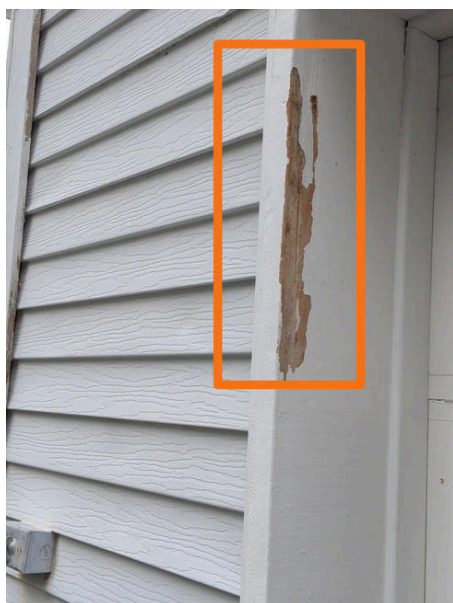
GARAGE

General repair due to age and lack of maintenance was needed at the fascia and eaves. Moisture damaged wood should be replaced/repared as needed as well as scraping, priming and painting. Some areas were being affected by roof runoff. Diverting rain water will help to prolong the life of the wood materials. Ignoring these areas will lead to further degradation. **Due to the age of the home some of the peeling paint may be lead based, use caution during removal.**

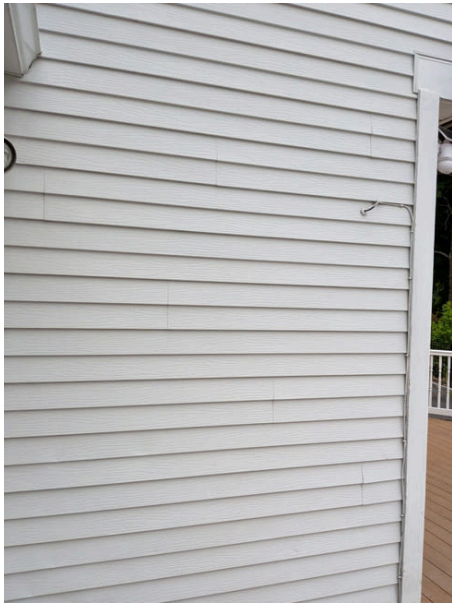
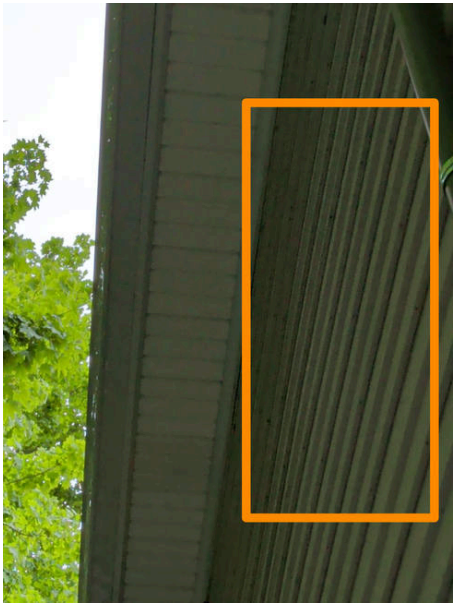
EXTERIOR WALL

During the exterior inspection, the aluminum panels on the exterior wall exhibited varying degrees of paint peeling, surface wear, and noticeable dirt accumulation. These conditions do not currently pose a safety hazard but may lead to accelerated corrosion if left unattended. It is recommended to monitor the panels closely and, when necessary, engage a qualified professional to clean the surfaces and perform any required repairs or repainting to preserve the panel integrity.

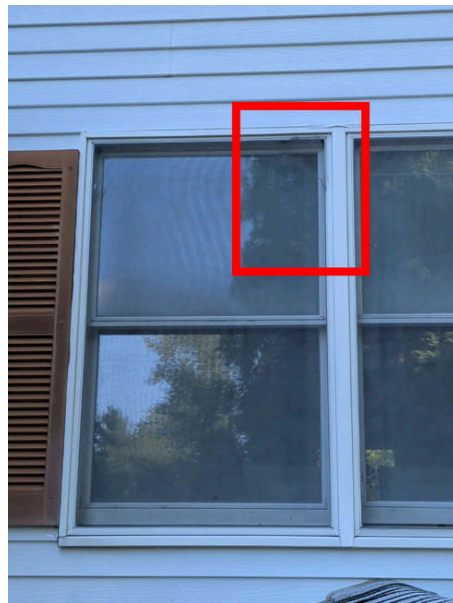
📍 WINDOWS

The screen's frame was damaged in the noted location(s), which may allow pest intrusion during window use. Recommend repair/replacement as needed.

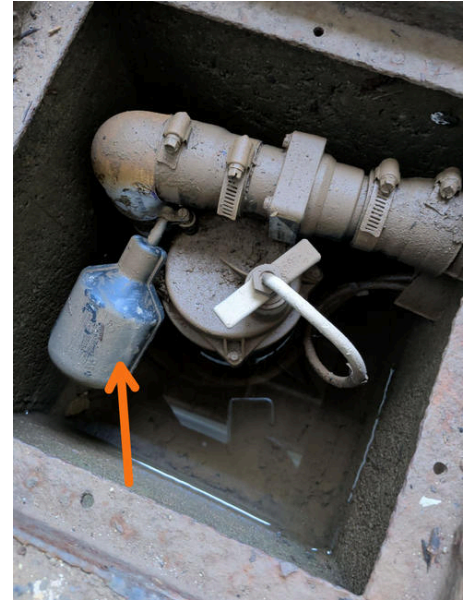
📍 BASEMENT, BACK YARD, WALKOUT-ENTRY

The **basement exit sump pit** is noticeably small, limiting water storage capacity. The associated **sump pump** exhibits a sluggish water-level control response, which may delay pump activation during rising water conditions. This delayed response can increase the risk of water intrusion into the basement. It is recommended to replace the existing pump with a unit that features a more sensitive and rapid water-level control mechanism to ensure timely water removal.

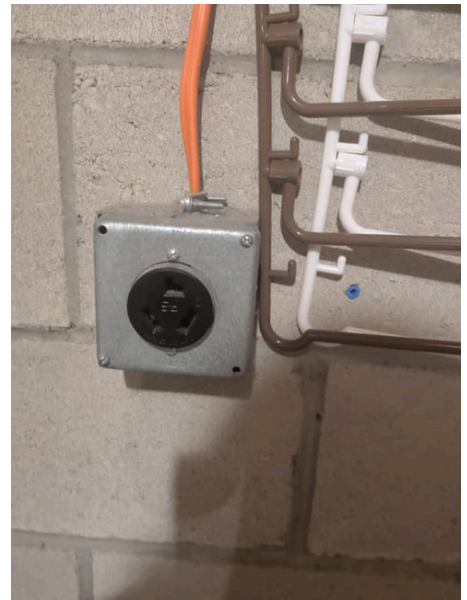
10.9.3 · GFCI & AFCI

Electrical Receptacle - GFCI Protection Verification

✔ Not GFCI Protected

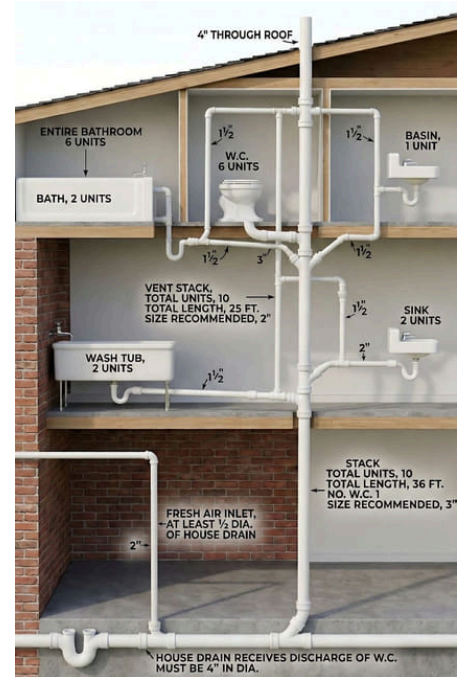
PVC was used for the plumbing vent stacks. PVC is not UV resistant and will get brittle with time. Although not required, it is recommended to paint PVC to protect it from the damaging effects of the sun.

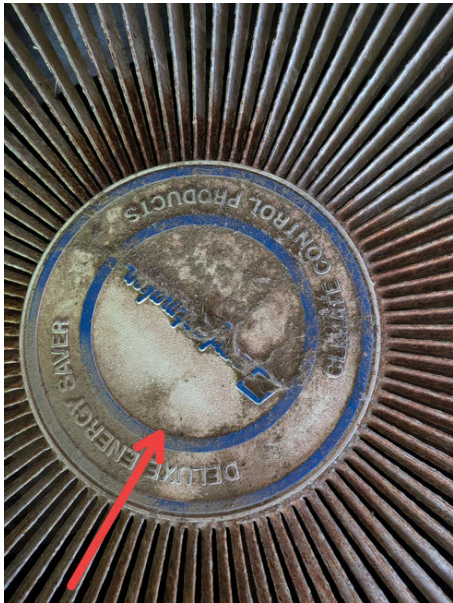
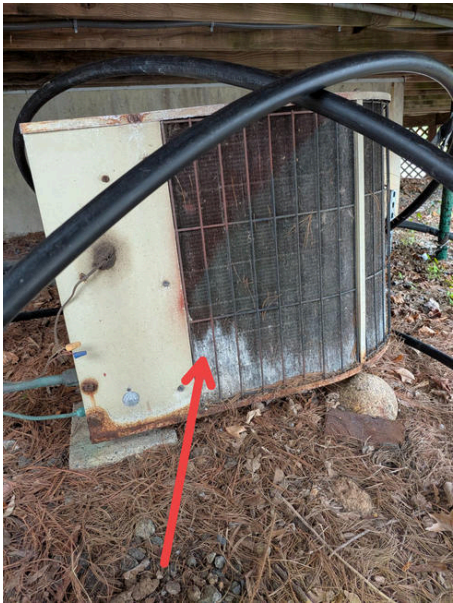
indicate reduced efficiency. It is recommended to replace the system with a new, code-compliant unit to improve performance and reduce energy costs.

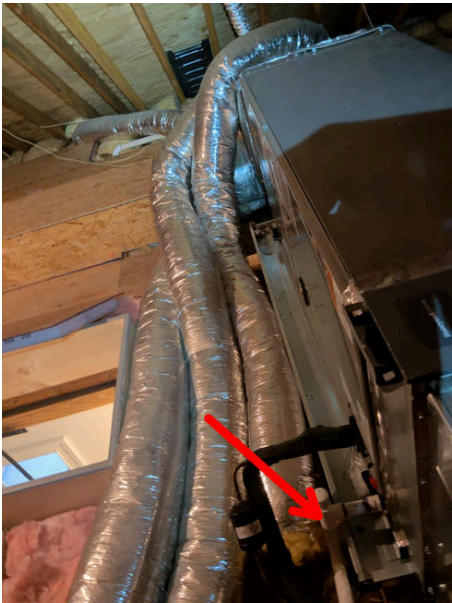
ATTIC

The spare condensate drain pipe was **missing** from the evaporator coil in the **Attic**. It is recommended to monitor the existing drainage system closely and install a spare drain pipe if needed to ensure continued protection against moisture accumulation.

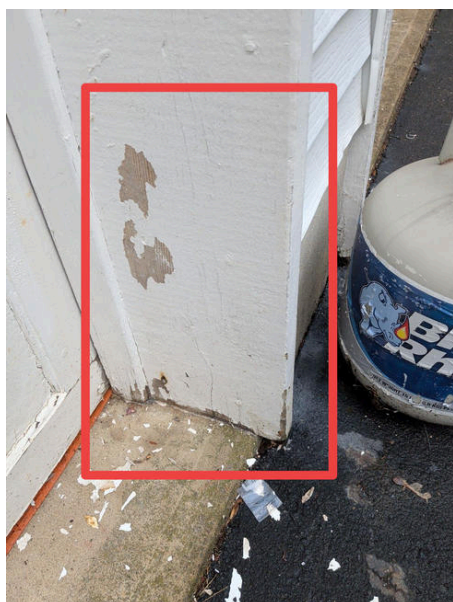
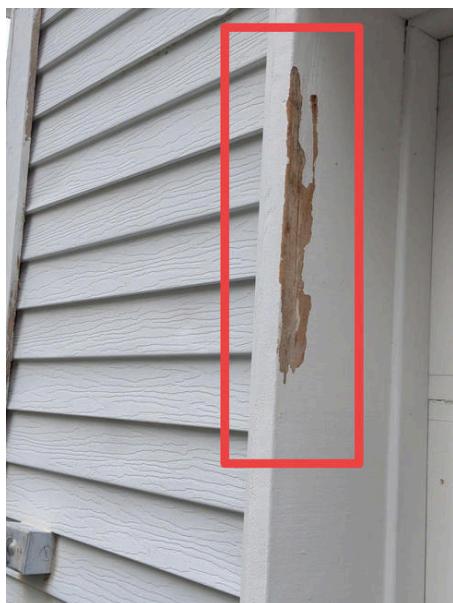
Peeling paint was observed at the time of inspection. Recommend repair as desired.
