**GRAND VIEW**  
Property Services

## RESIDENTIAL INSPECTION

**August 25, 2026**

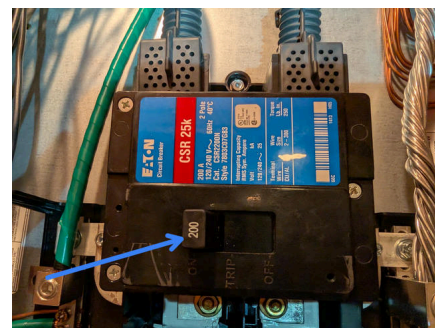
### 2.1.2 · Electric Service Shutoff

The main **electrical service disconnect**, as shown in the photograph, provides a single point of control that can interrupt all electrical power to the residence. This device is designed to be used in emergencies or for routine servicing of the electrical system. The disconnect is properly labeled and appears to be readily accessible at the service entrance.

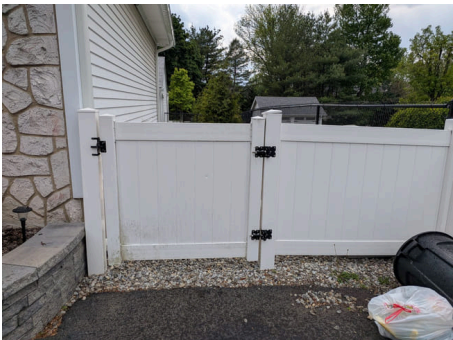
Fence - Condition

The fence on the front-yard left side, viewed from the front door looking toward the street, is constructed of white PVC. During the inspection no obvious blemishes, cracks, rot, or other visible defects were observed. The surface appears intact and the material shows no signs of deterioration or damage.

Continue periodic visual checks, especially after severe weather, to ensure the fence remains in good condition.

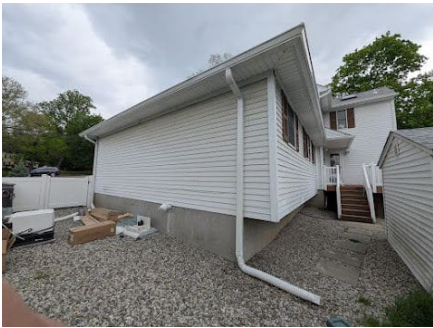
📍 Walk Path

The walkpath was inspected visually and no obvious safety or structural defects were observed. The surface appears level, free of cracks, breaks, or hazardous conditions, and the surrounding grading provides adequate drainage. Maintaining clear access and regular upkeep will help preserve its condition. No corrective actions are required at this time.

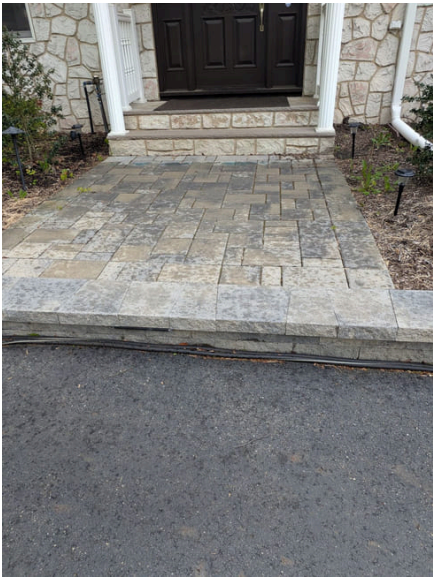
📍 Main entrance patio

Patio - Normal Operational Condition

The main entrance patio was visually inspected and no obvious defects were observed. All surface materials appear intact, and there are no signs of cracking, spalling, or water intrusion. The patio grading and drainage seem adequate, and the overall condition aligns with the expected performance for a well-maintained exterior area.

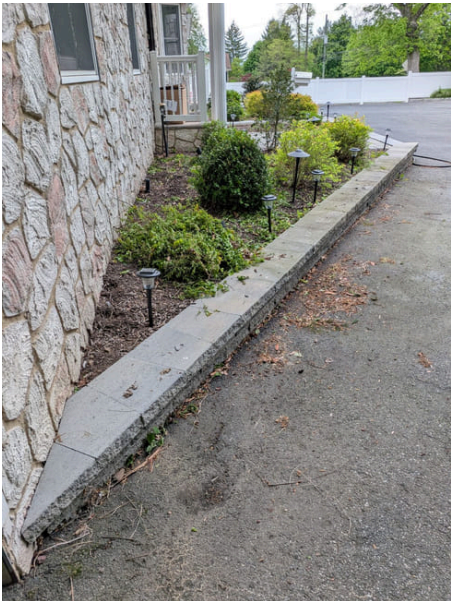
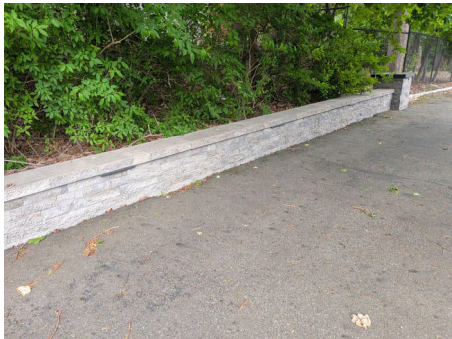
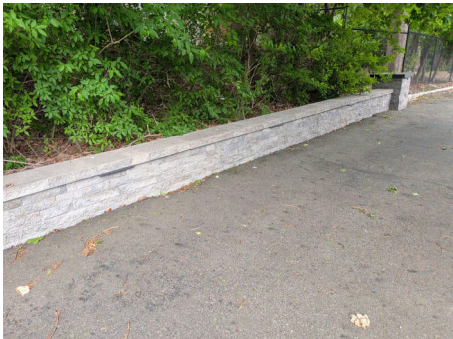
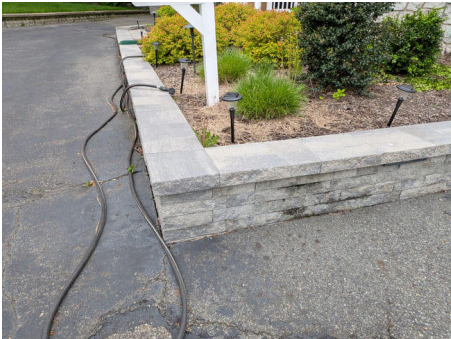
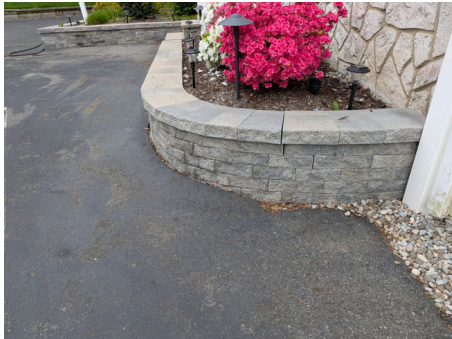
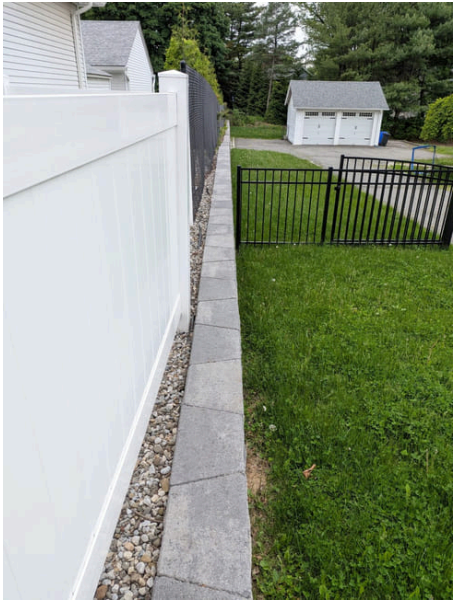
#### Retaining Wall - Condition

The retaining wall was inspected and found to be in overall good condition with no visible defects or obvious flaws observed. No cracks, leaning, or separation were noted during the visual examination.

**Recommendation:** Continue periodic visual monitoring of the wall to ensure any future changes are detected early. Routine maintenance such as clearing vegetation and checking drainage can help preserve its condition.

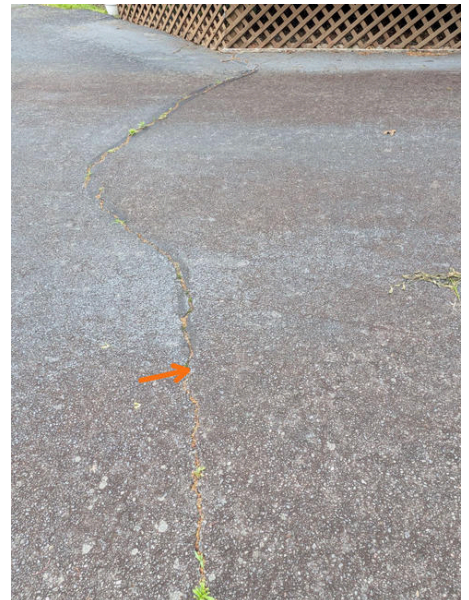
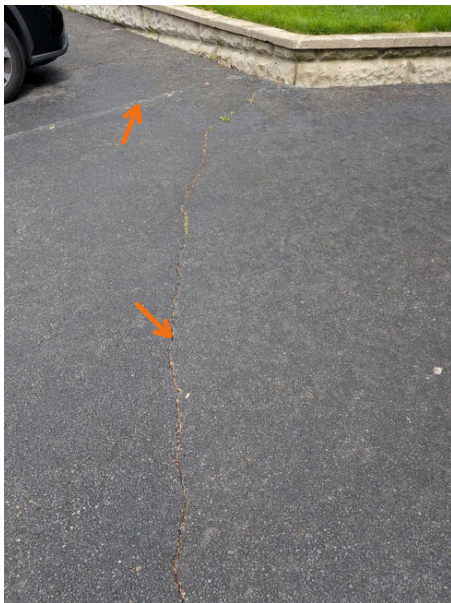
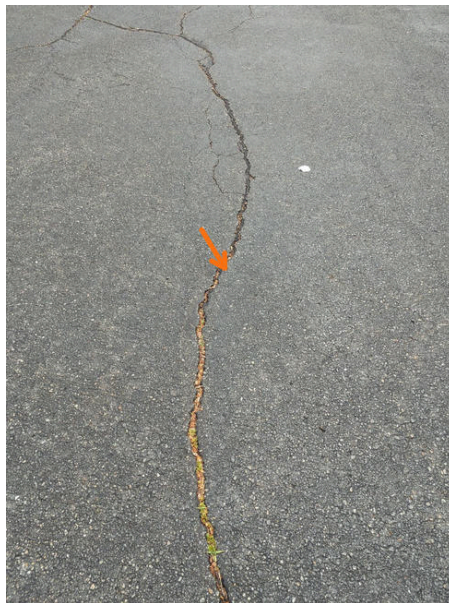
### Driveway - Damage/Cracking

Damage/cracking was observed on the driveway surface. Recommend repair as desired.

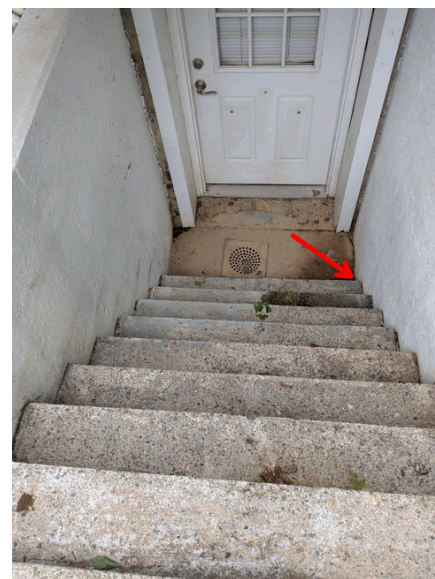
##### BASEMENT WALKOUT STAIRS LEFT SIDE

#### Basement Walkout Stairs - Retaining Wall Moisture Intrusion

During the inspection, rain water seepage was observed at the base of the retaining wall on the left side of the face to outside from the walkout door of the basement walk-out stairs. The moisture appears to be entering the wall cavity, creating a potential pathway for water to reach the basement interior. **Recommendation:** Repair the retaining wall and improve drainage promptly to prevent surface water from infiltrating the basement and causing further damage.

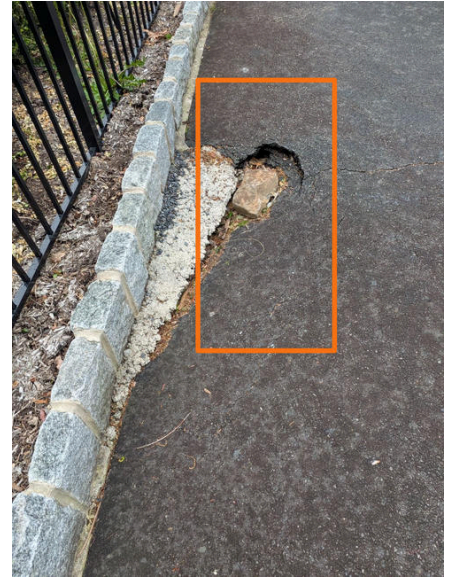
📍 BACKYARD PARKING LOT

During the inspection a **pit** was observed in the **Backyard Parking Lot**. The pit appears to have been formed by **surface water** erosion, creating a low spot that can collect water and pose a slip hazard. It is recommended that the pit be repaired promptly and that the surrounding grading be re-contoured to provide a positive slope away from the parking area, directing surface water safely away from the foundation and other hard-scaped surfaces.

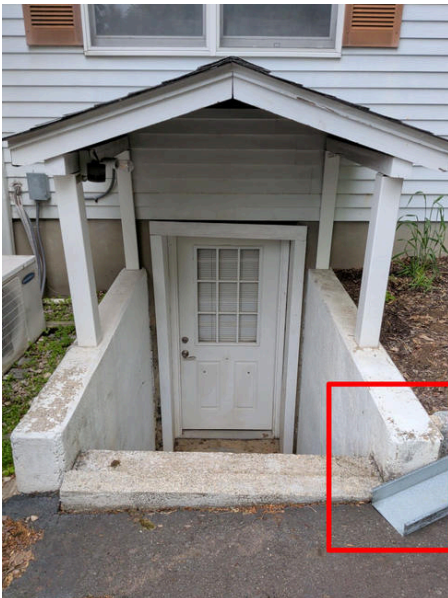
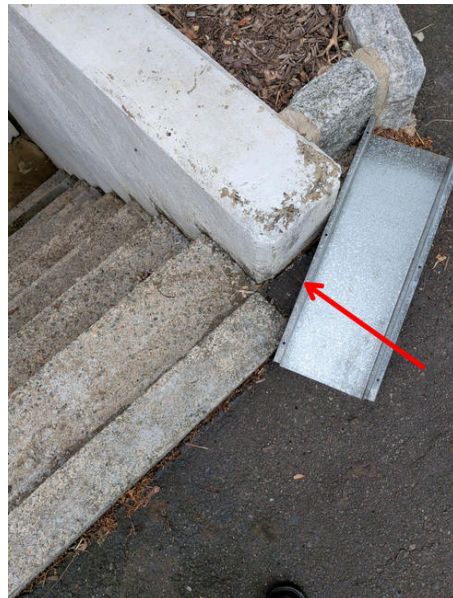
📍 BASEMENT WALKOUT STAIRS TOP LEFT SIDE, DRIVEWAY

**Basement Walkout Stairs - Step Water Infiltration**

At the top left side of the walk-out stair treads, visible water infiltration was noted where surface water has collected against the step. This condition indicates inadequate grading or drainage, allowing water to pool and potentially seep into the stair structure. **Recommendation:** Regrade the area and install proper drainage to direct water away from the steps, thereby protecting the stair assembly and the basement below.

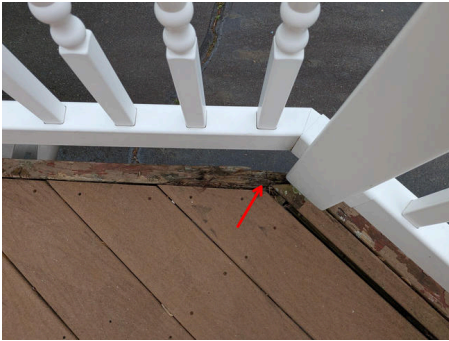
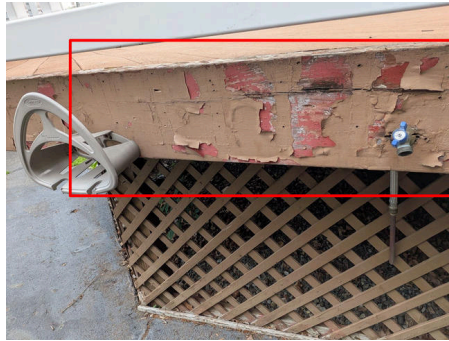
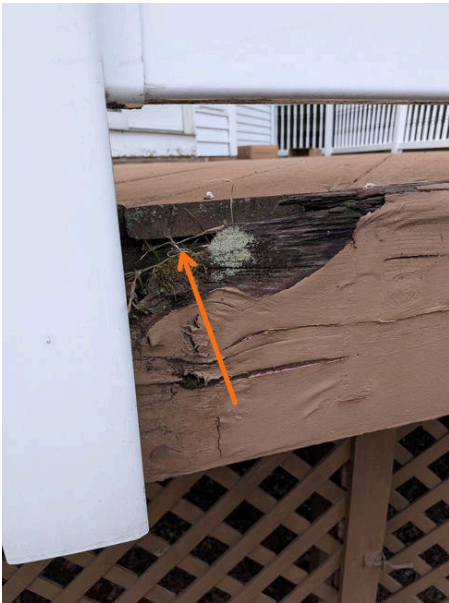
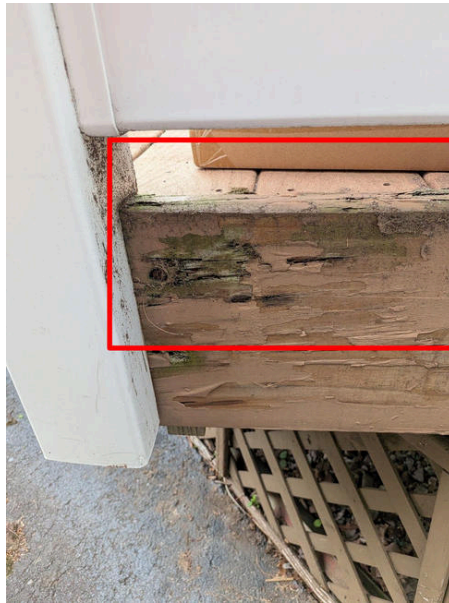
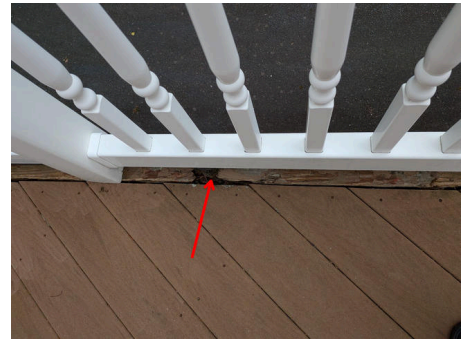
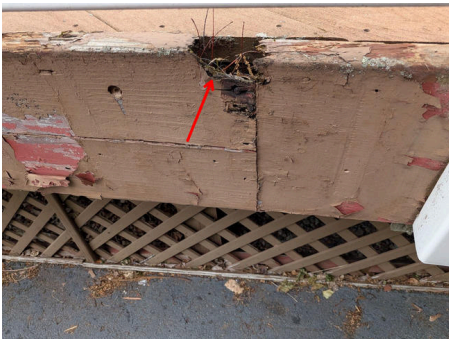
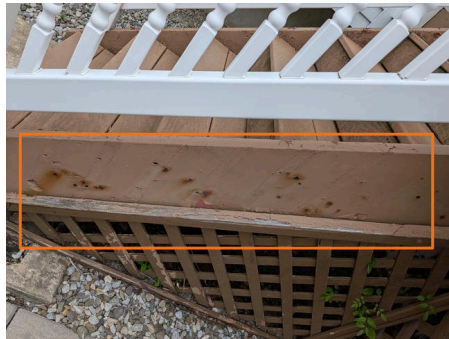
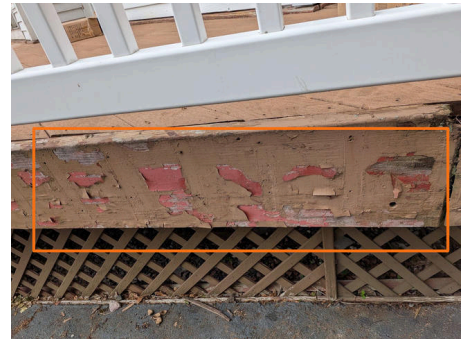
📍 DECK

**Deck Beam - Damage**

Moisture and wood destroying organism damage was observed on the deck beam. Recommend further evaluation and replacement of damaged beam as needed.

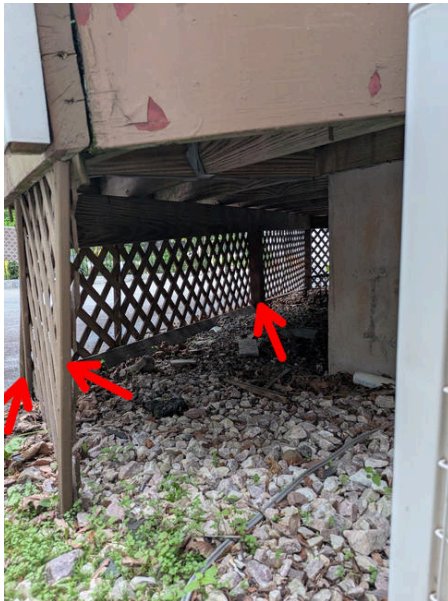
📍 DECK

Some of the deck posts were in contact with the ground or had moist dirt at the base. This will likely accelerate degradation due to potential moisture damage. Recommend ensuring debris is away from the post to limit damage over time. *All may not be shown.*

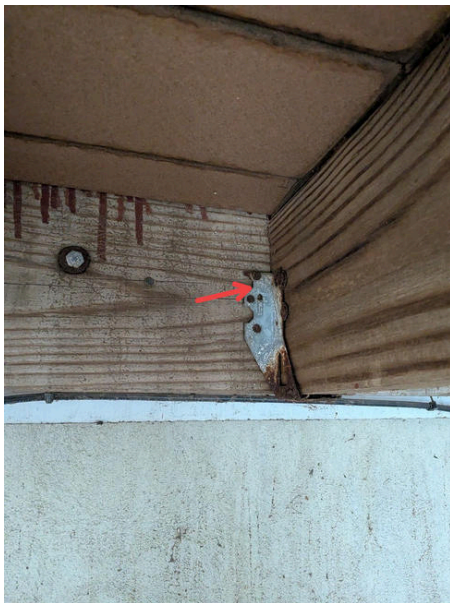
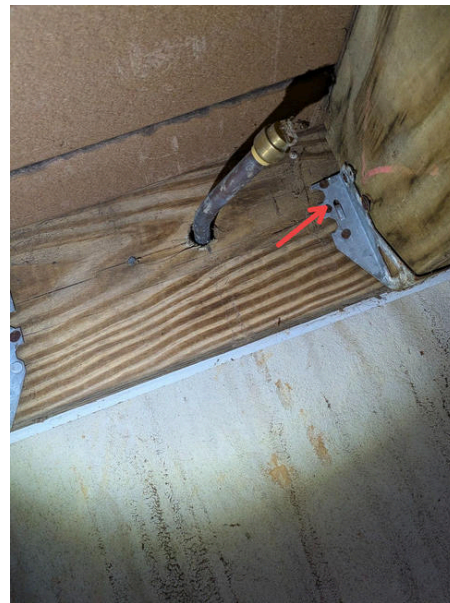
📍 DECK

**Deck - Hanger Screw Loose/Missing (Safety)**

The hanger screws between the deck and the ledger board are observed to be loose or missing. This condition constitutes a safety defect because it can allow deck components to become unsecured, creating a risk of collapse or injury. Immediate repair is recommended to re-install or tighten the hanger screws and ensure proper attachment of the deck to the ledger board.

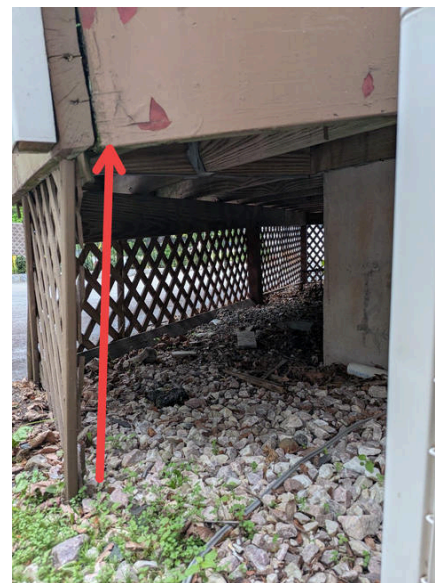
DECK NEAR BASEMENT WALKOUT

### Deck - Missing Support Posts

During the inspection, the deck area adjacent to the basement walkout was observed to have missing support posts, resulting in a suspended deck surface. This condition constitutes a **safety hazard** because the deck lacks proper structural support and could fail under load. It is recommended that a qualified contractor install appropriate support posts and reinforce the deck framing promptly to restore safe load-bearing capacity.

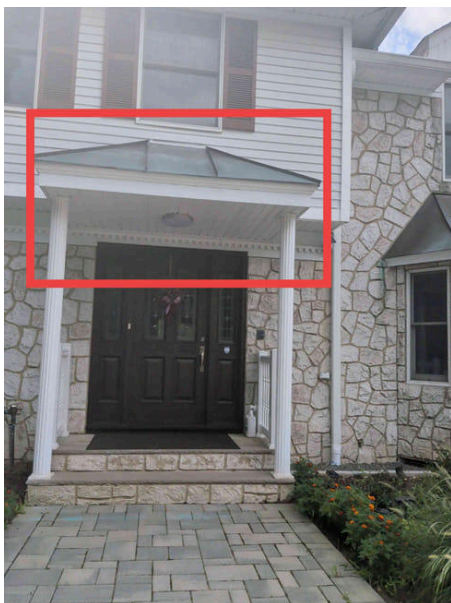
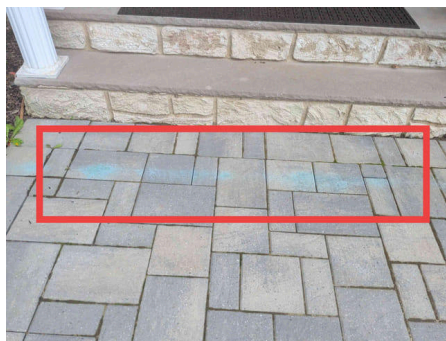
MAIN ENTRANCE PORCH

### Gutter and downspout Missing

A gutter /downspout was missing in the noted location(s) which was causing erosion to the ground below. Recommend installation with proper downspouts to redirect water from home.

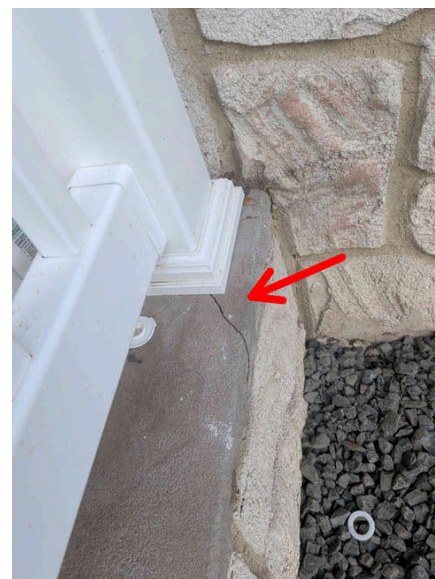
**Porch - Cracks**

The stone surface of the front porch exhibits visible cracks. These cracks can allow water infiltration, and during winter freeze-thaw cycles the moisture may expand, worsening the damage and potentially leading to further deterioration of the stone and underlying substrate.

It is recommended to repair the cracked stones promptly to prevent moisture intrusion and freeze-thaw related degradation.

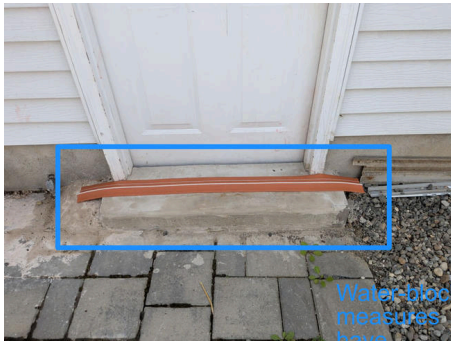
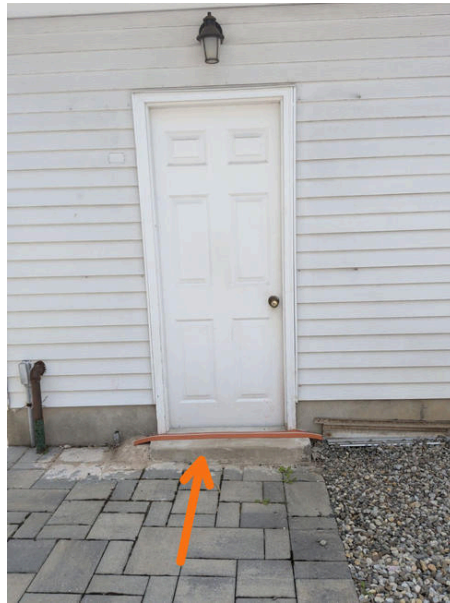
**Improper Drainage**

At the front of garage door, the grading transition between the driveway, the garage entrance slab, and the adjacent walk path is minimal, creating a low spot where surface water accumulates during heavy rain. Standing water was observed pooling at the foundation line and the garage floor indicating inadequate drainage away from the structure.

**Recommendation:** Install a French drain or re-grade the area to direct runoff away from the garage foundation, and consider adding swales or other drainage improvements.

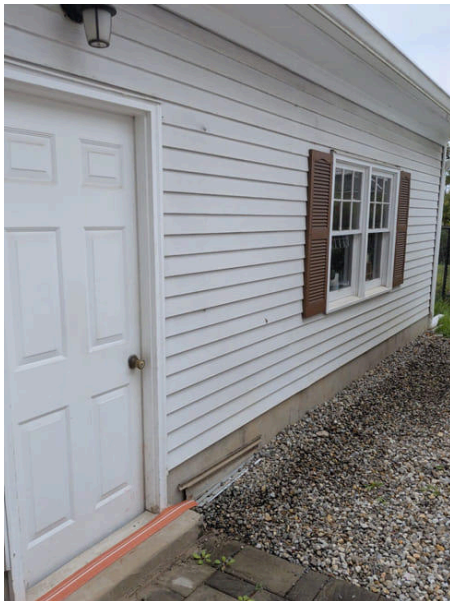
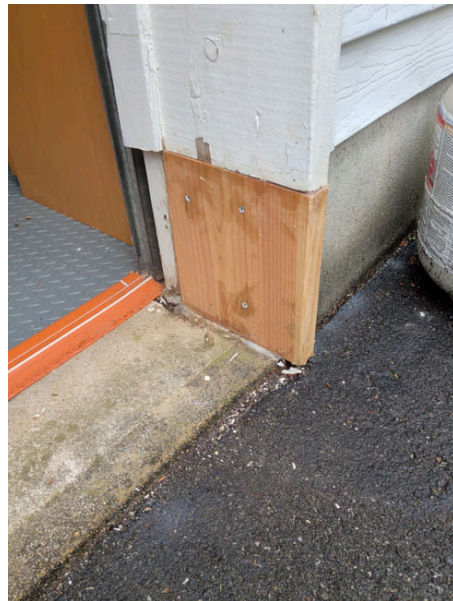
### Improper Drainage

Standing water (ponding) observed near the foundation or in the yard. **Action:** Install a French drain or improve surface swales.

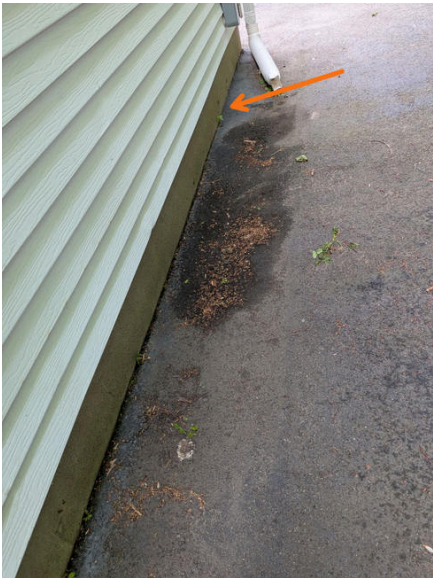
RIGHT SIDE FOUNDATION WALL

Grading - Negative Slope Toward Foundation

The grading adjacent to the right-side foundation wall slopes toward the structure, creating a negative slope that directs rainwater toward the foundation base.

This condition can cause water accumulation at the footing, increase hydrostatic pressure, and elevate the likelihood of basement water intrusion, wall cracking, or wood rot.

It is recommended that a qualified landscape or grading contractor re-grade the area to achieve a minimum six-foot outward slope away from the foundation to provide proper drainage.

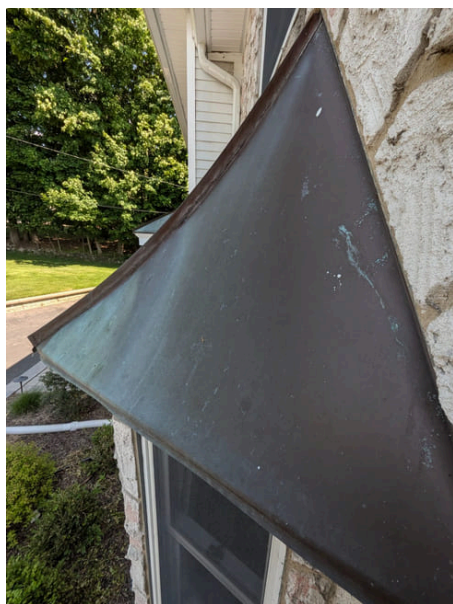
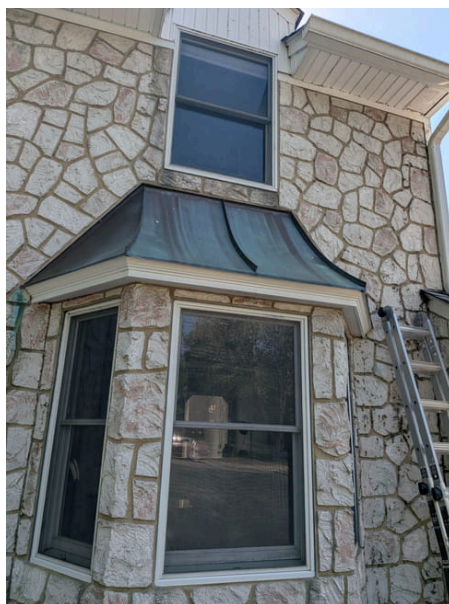
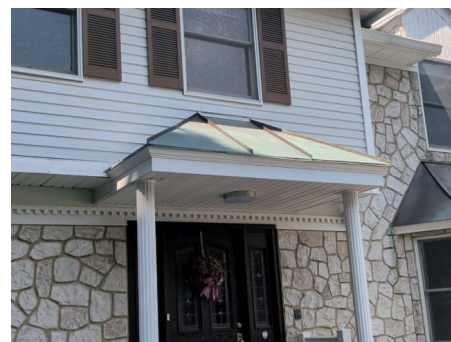
The roof material observed at the Main entrance porch and bay window is copper. Copper roofing provides excellent durability and corrosion resistance, but it requires periodic inspection to ensure seams remain intact and fasteners are secure.

Recommend a visual inspection of seams and fasteners annually and consider a protective coating in harsh environments.

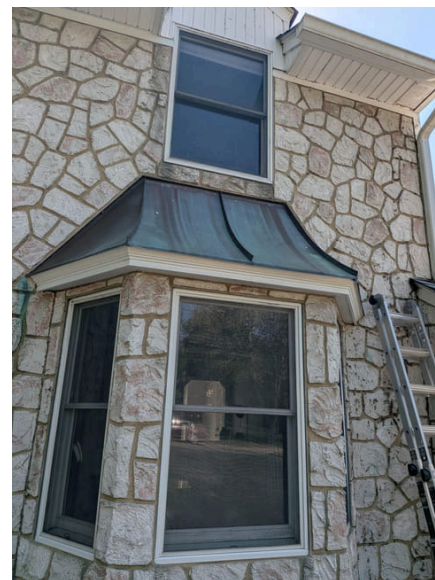
The roof material observed at the Family room bay window is copper. Copper offers long-term durability and natural resistance to corrosion, but seams and flashing should be checked regularly for integrity.

Recommend an annual visual inspection of the copper seams and flashing, and apply a protective sealant if the roof is exposed to aggressive weather conditions.

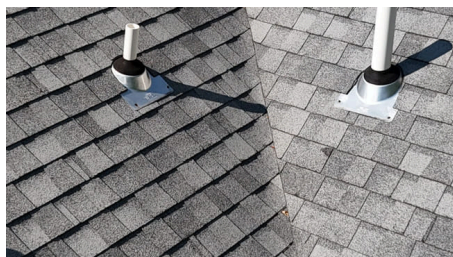
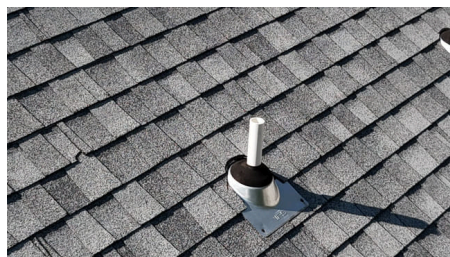
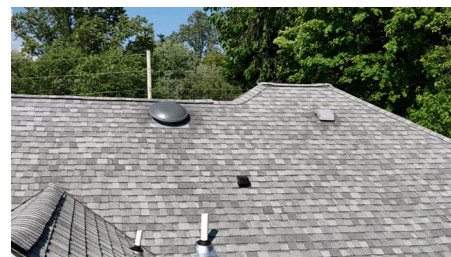
### Plumbing Vent - Good Condition

The roof plumbing vent waterproofing and installation overall condition is good. No obvious defects were observed during the inspection. The vent appears properly sealed and securely mounted, with no signs of moisture intrusion, corrosion, or damage.

It is recommended to perform periodic visual inspections to confirm the vent remains in this satisfactory condition.

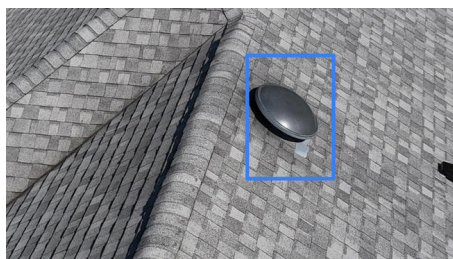
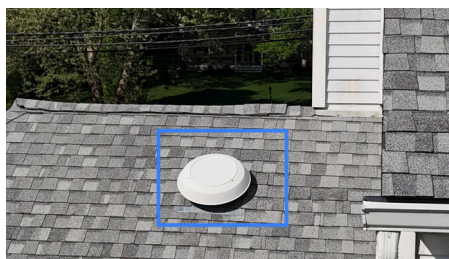
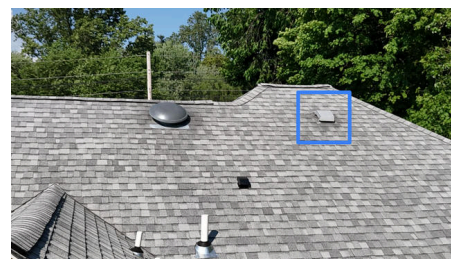
Attic

The attic ventilation system employs four distinct methods: **soffits**, **gable vent**, **power fan**, and a **turtle box**. All four were observed to be installed and functional during the inspection.

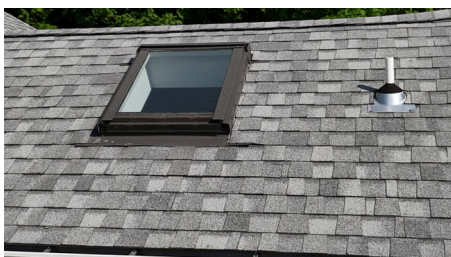
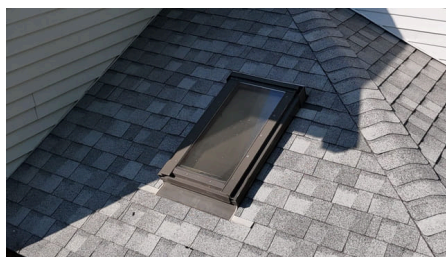
Roof

The roof includes two fixed skylights. **One skylight** is located above the kitchen area on the first floor, and **the second skylight** is positioned over the master bedroom bathroom on the second floor. Both units were clearly visible during the visual inspection and no obvious installation defects were observed. Their glazing appears intact and there is no evidence of water intrusion at the time of inspection.

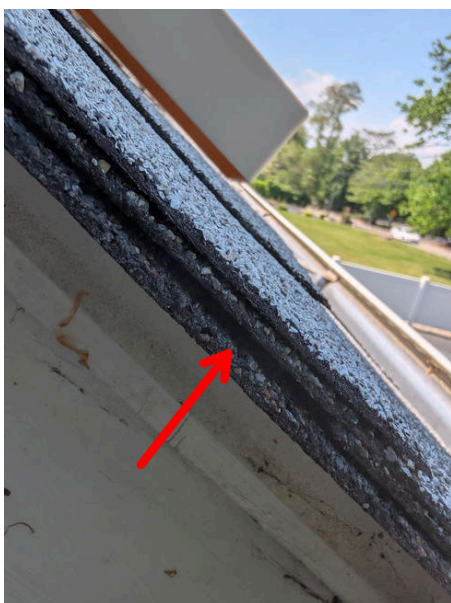
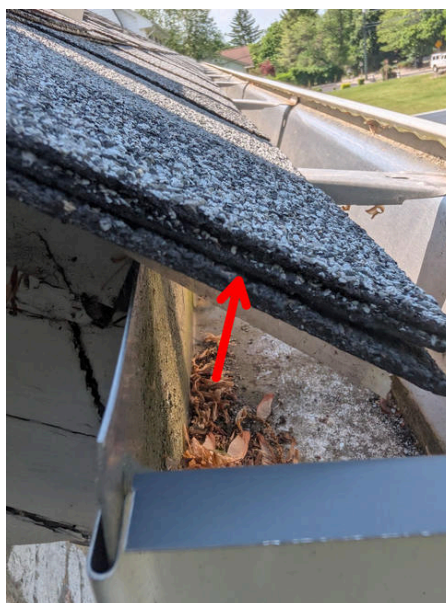
The roof consists of two layers of shingles. During the 2019 roof replacement, the original roof material was not cleared before installing the new shingles. This can trap moisture and reduce the lifespan of the new roof system.

**Recommendation:** Closely monitor the roof condition and, when the next replacement is required, fully remove the existing roofing material and reinstall the new roof in accordance with applicable building codes and manufacturer specifications.

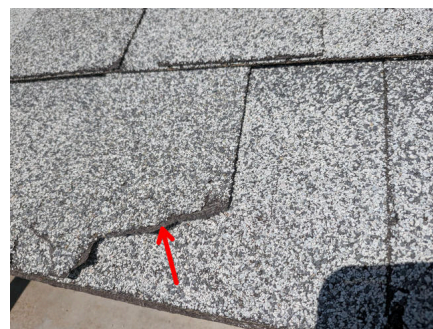
📍 ROOF

#### Roof Tiles - Damaged

During the roof inspection, several tiles were observed with edge **damage**. The damaged areas could allow water infiltration if not addressed. It is recommended to monitor these tiles closely for any signs of leakage and consider repair or replacement of the affected tiles to maintain roof integrity. Additionally, ensure that any surrounding flashing remains intact.

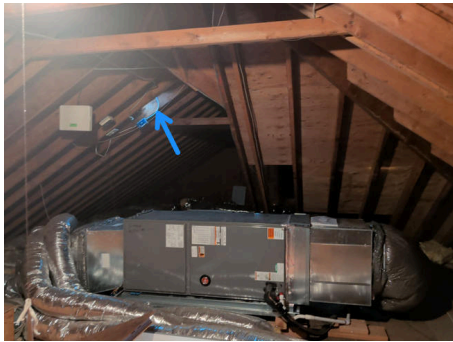
Using the four ventilation methods simultaneously creates an **airflow short-circuit**, which reduces overall ventilation effectiveness in the attic. The combined operation of the **turtle box** and **gable vent** with the **soffits** and **power fan** short-circuits the intended airflow path.

**Recommendation:** Close the **turtle box** and the **gable vent**, retaining only the **soffits** and **power fan** to restore proper ventilation.

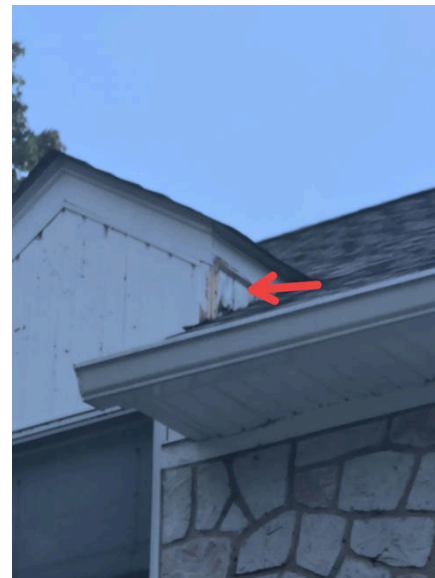
##### **Dormer Window Apron Flashing - Improper Installation**

The apron flashing at the front lower portion of the dormer window is installed beneath the roofing shingles, creating a reverse water overlap that allows rainwater to flow directly beneath the roof.

**Recommendation:** Re-install the flashing above the shingles to ensure proper water shedding and prevent potential water intrusion.

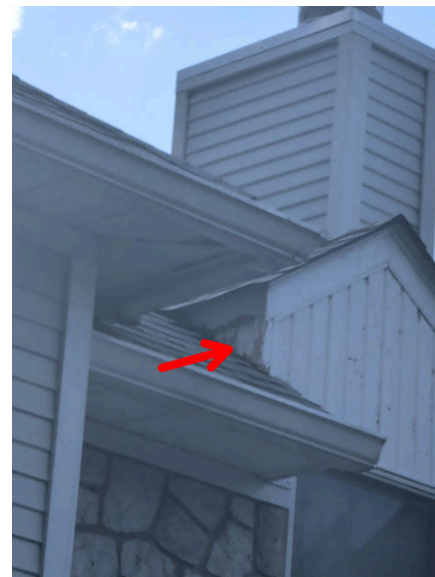
📍 DORMER

##### **Improper Siding Clearance to Roof Tiles**

**Exterior siding** of the **dormer siding** directly contacts the **roof shingles** with no 1-2 in. clearance. This lack of gap allows capillary water absorption, which can cause wood siding rot or fiber-cement delamination and hinders tile replacement and proper drainage.

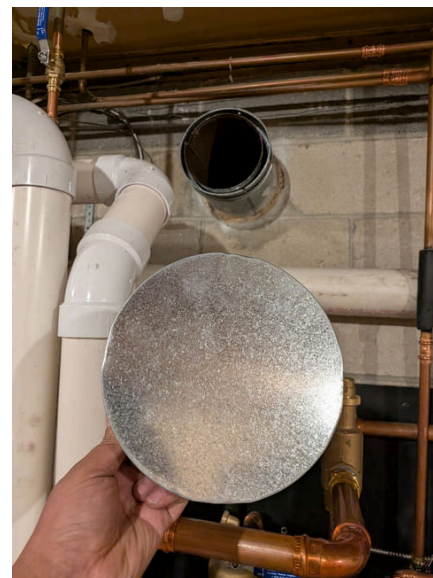
### Chimney Liner - Abandoned Furnace

The chimney liner includes a second B-type galvanized steel chimney that was originally used for a furnace and is now abandoned.

An abandoned galvanized steel liner may be prone to corrosion and can allow moisture to enter the chimney cavity. It is recommended to evaluate the condition of the abandoned liner and consider removal or proper sealing to prevent potential water intrusion and corrosion.

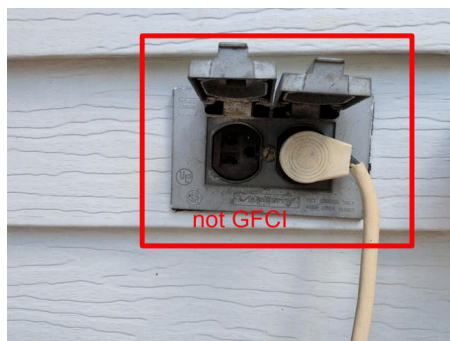
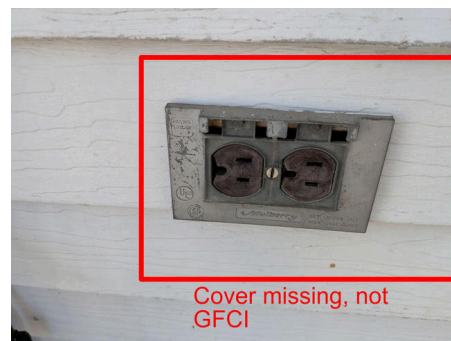
*Outlets used in wet locations should be equipped with an in-use (bubble) cover to prevent moisture intrusion, which can lead to corrosion, malfunction, or electrical shock hazards.*

#### ✓ Cover missing

*Any outlet lacking a proper cover, or with a damaged cover, should be corrected to meet safety standards.*

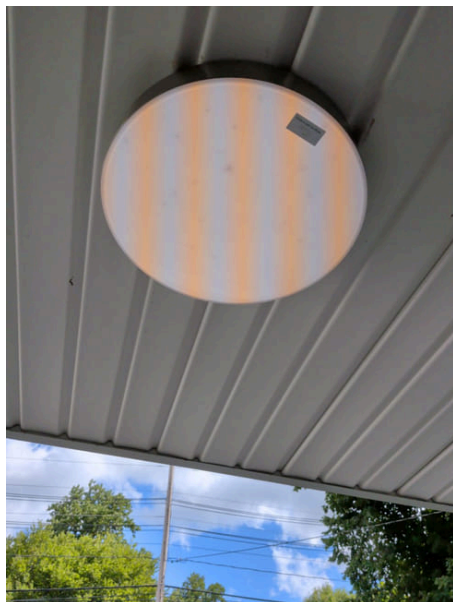
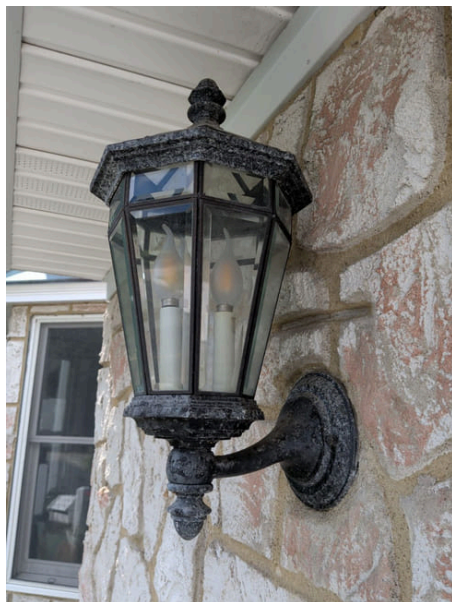
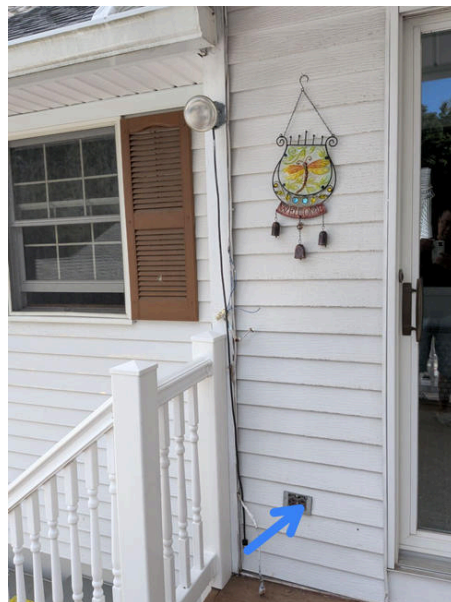
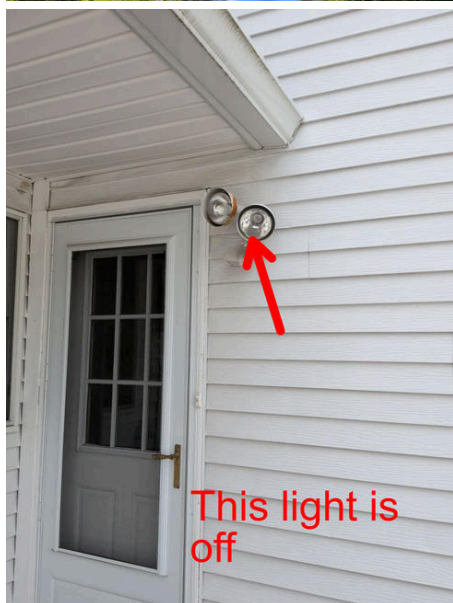
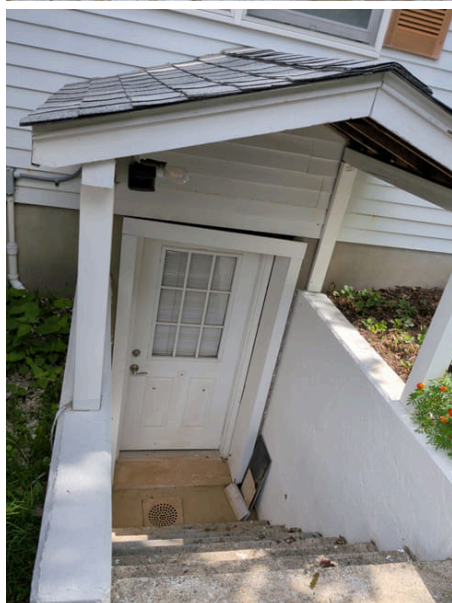
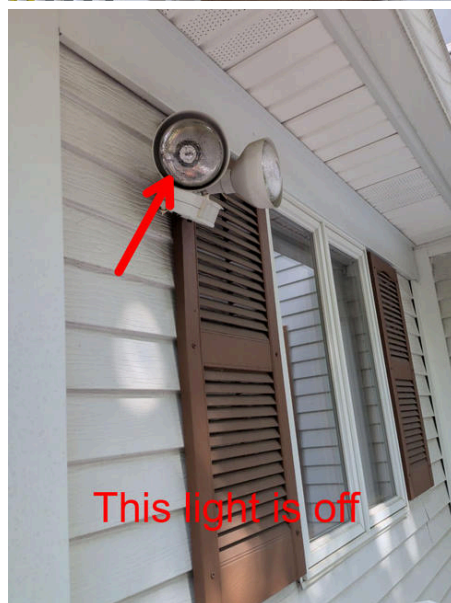
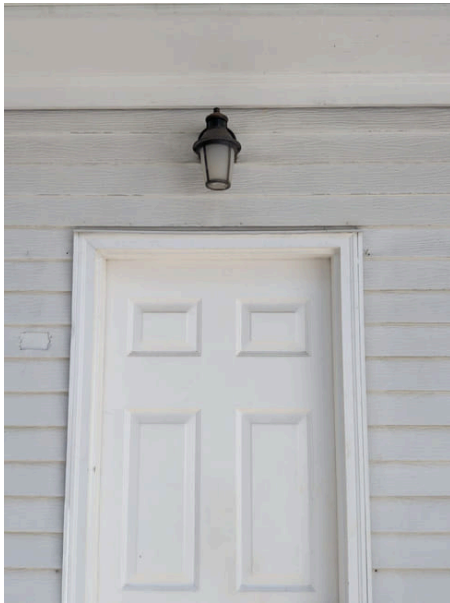
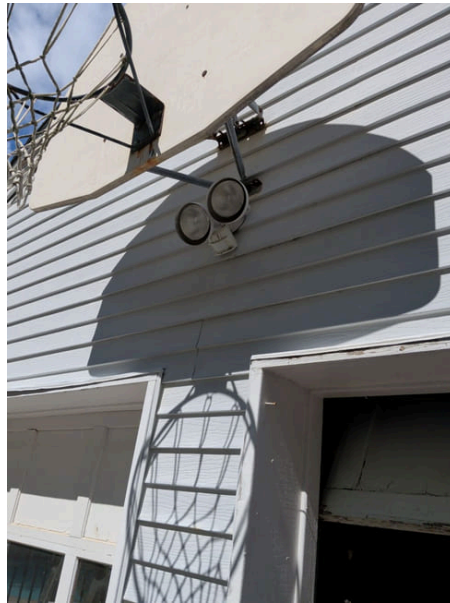
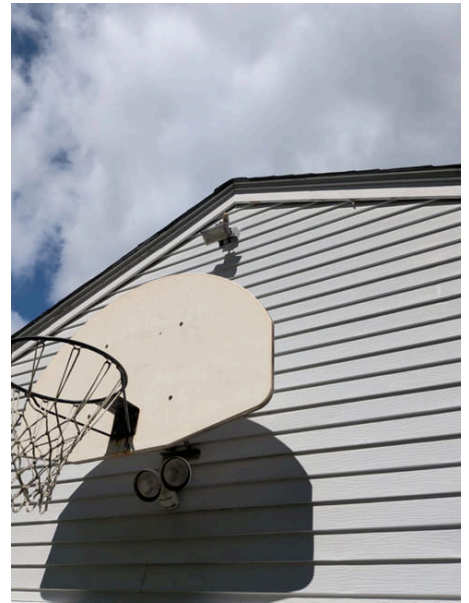
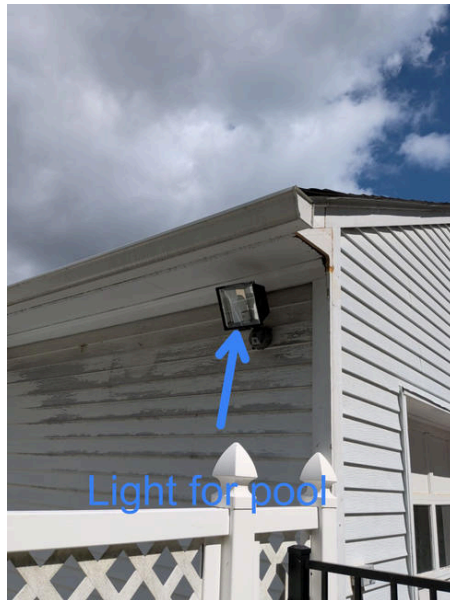
#### 5.14.1 · Exterior Lights Fixture

Each fixture was evaluated for proper mounting, secure attachment, condition of the housing, and functional operation of the lamp(s). Control switches were examined for correct wiring, secure connections, and operability from both interior and exterior locations. No signs of corrosion, cracked housings, or exposed wiring were observed on the majority of units. However, a few fixtures exhibited diminished illumination, likely due to aged bulbs or partial failure of the fixture components. Several control switches displayed intermittent operation, suggesting possible wear in the switch mechanism or loose connections.

✓ **Functional**

Based on these observations, it is recommended to replace any non-functioning bulbs, repair or replace defective fixtures, and address any faulty switch mechanisms to ensure reliable exterior lighting, which is essential for safety and security.

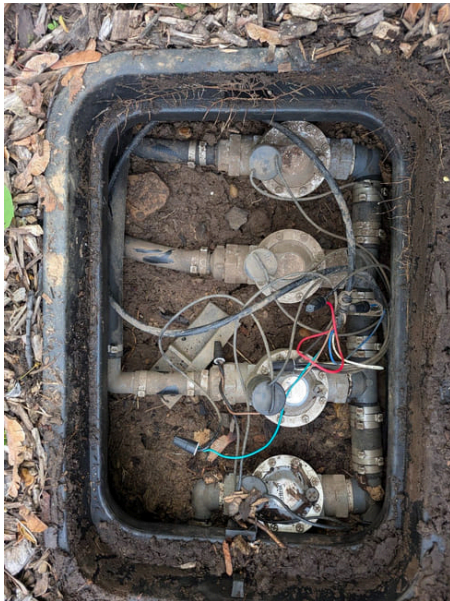
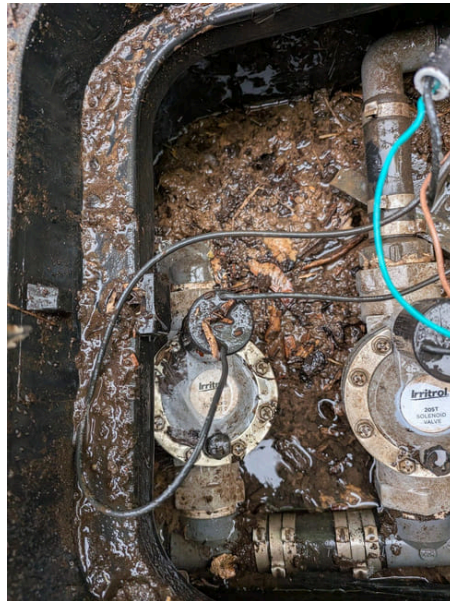
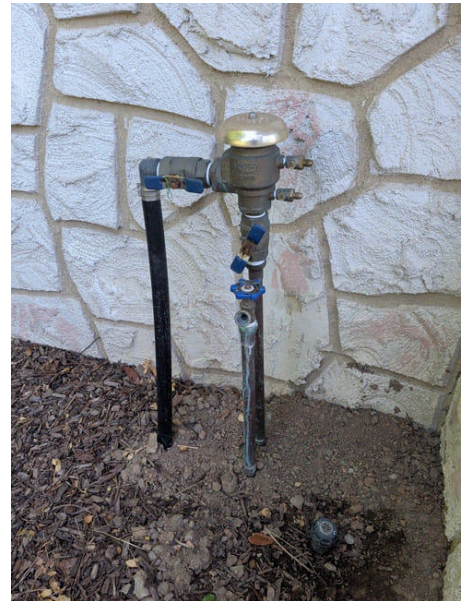
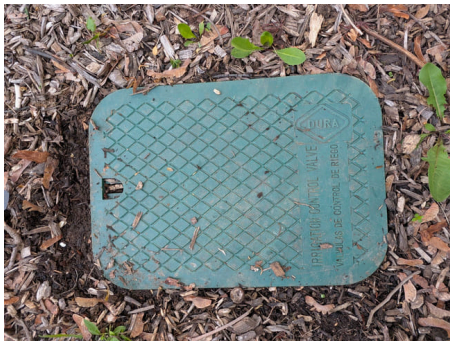
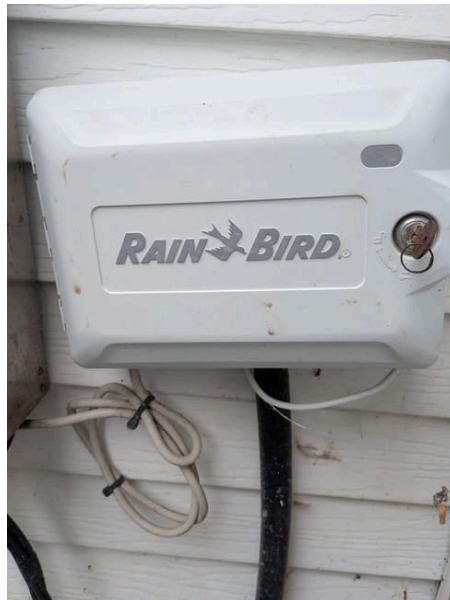
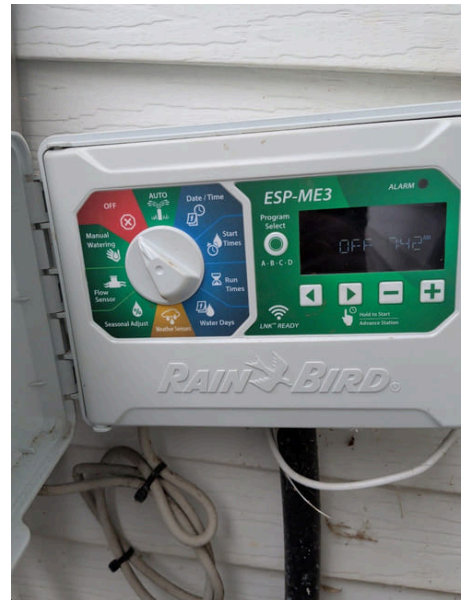
5.15.1 · Irrigation System

The Irrigation system was tested and found to be operative at the time of inspection.

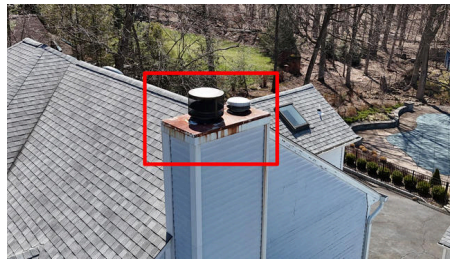
5.1.10 · Chimneys-outside And Inside

Chimney Cap - Rust

The chimney cap was originally constructed of iron sheet material and were observed to be severely rusted. The trim was wood and was observed to be rot. The current homeowner engaged a roofing contractor in April 2026 to replace the cap with stainless steel and the trim with aluminum. The replacement appears to have been completed. It is recommended to periodically inspect the new stainless steel cap and aluminum trim for any signs of corrosion or wear to ensure continued protection.

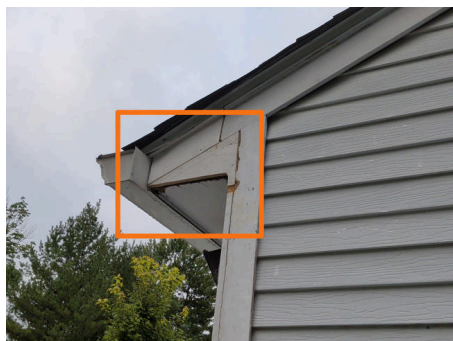
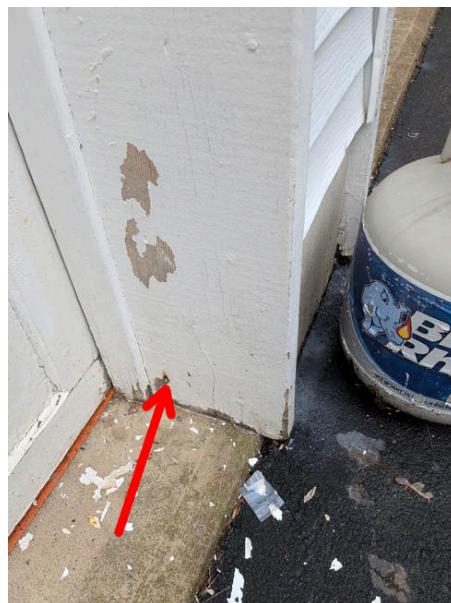
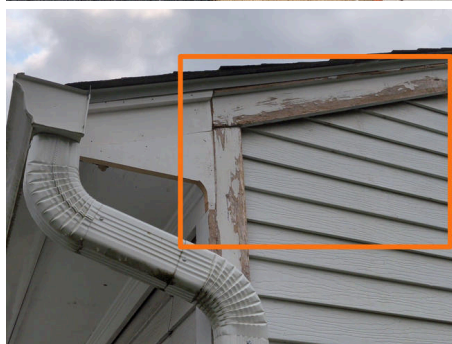
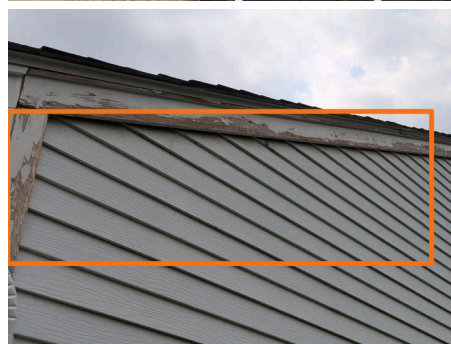
GARAGE

General repair due to age and lack of maintenance was needed at the fascia and eaves. Moisture damaged wood should be replaced/repared as needed as well as scraping, priming and painting. Some areas were being affected by roof runoff. Diverting rain water will help to prolong the life of the wood materials. Ignoring these areas will lead to further degradation. **Due to the age of the home some of the peeling paint may be lead based, use caution during removal.**

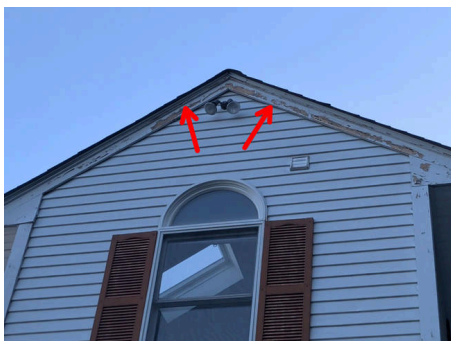
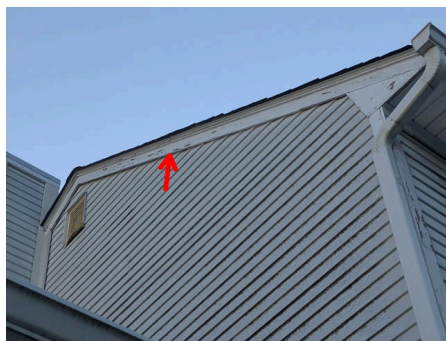
##### Fascia - Paint Peeling & Wood Rot

The fascia board shows extensive paint peeling and visible wood rot, indicating moisture damage and lack of maintenance. **Recommendation:** Have a professional contractor perform thorough repairs, including removal of deteriorated wood, repainting, and sealing to protect against future moisture intrusion.

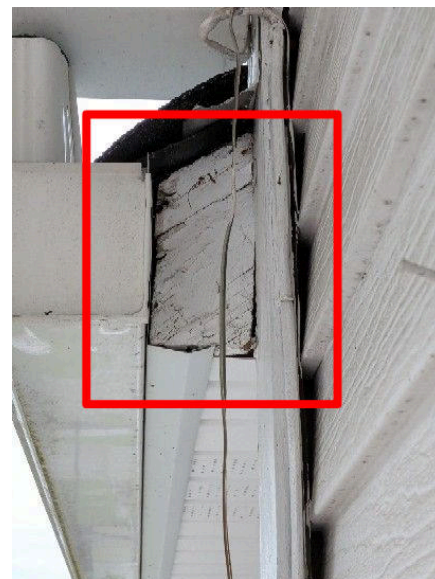
The fascia board exhibits holes that allow bird entry, creating potential entry points for wildlife and possible moisture intrusion.

**Recommendation:** Engage a qualified contractor to repair or replace the affected sections promptly to prevent further damage and maintain the integrity of the exterior envelope.

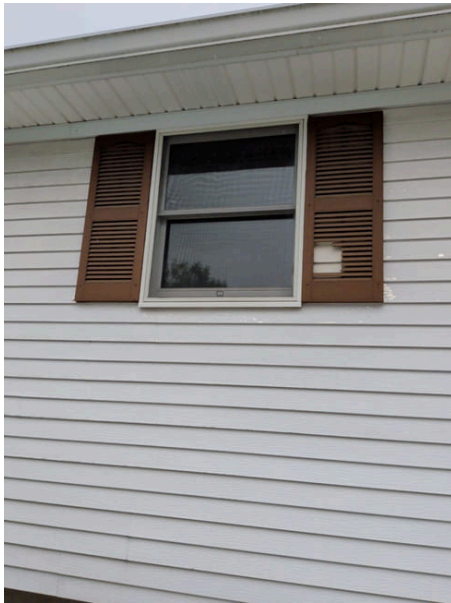
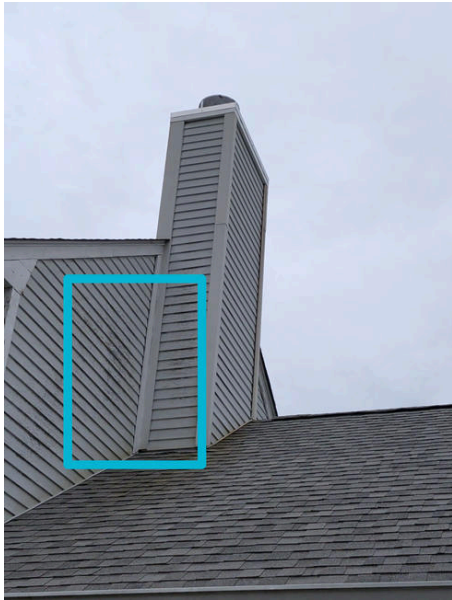
EXTERIOR WALL

##### Aluminum Panel - Paint Peeling, Surface Wear, Dirt

During the exterior inspection, the aluminum panels on the exterior wall exhibited varying degrees of paint peeling, surface wear, and noticeable dirt accumulation. These conditions do not currently pose a safety hazard but may lead to accelerated corrosion if left unattended. It is recommended to monitor the panels closely and, when necessary, engage a qualified professional to clean the surfaces and perform any required repairs or repainting to preserve the panel integrity.
