**GRAND VIEW**  
Property Services

## RESIDENTIAL INSPECTION

**August 25, 2026**

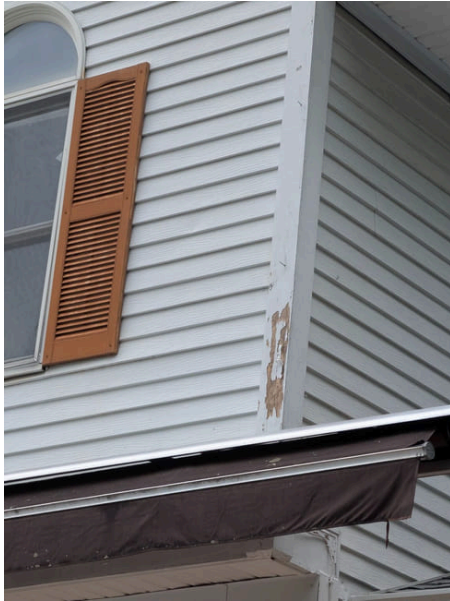
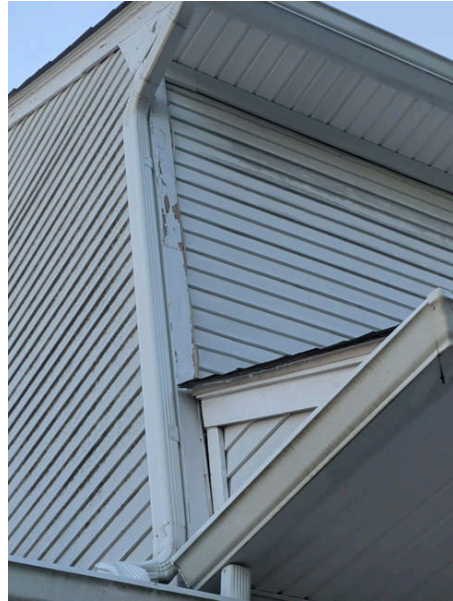
### Exterior Trim - Paint Peeling & Minor Rot

The exterior wooden trim at the wall corner exhibits extensive **paint peeling** and **minor rot** of the wood substrate.

Recommendation: Perform a thorough repair of the affected area. For a long-term solution, replace the deteriorated trim with a low-maintenance material such as PVC or aluminum.

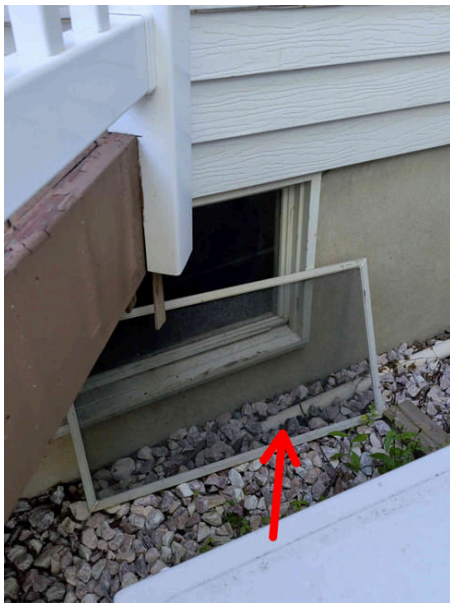
📍 WINDOWS

### Screen(s) Frame Damaged

The screen's frame was damaged in the noted location(s), which may allow pest intrusion during window use. Recommend repair/replacement as needed.

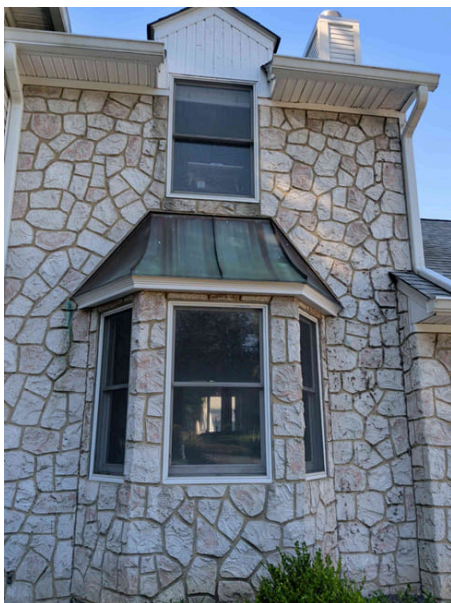
The street-facing windows are wood-frame, single-pane glass. While the overall function meets basic use requirements, the insulation and sound performance are poor, which can lead to increased energy costs and reduced interior comfort.

Recommendation: Replace the existing windows with modern insulated acoustic windows to improve thermal efficiency and reduce external noise transmission.

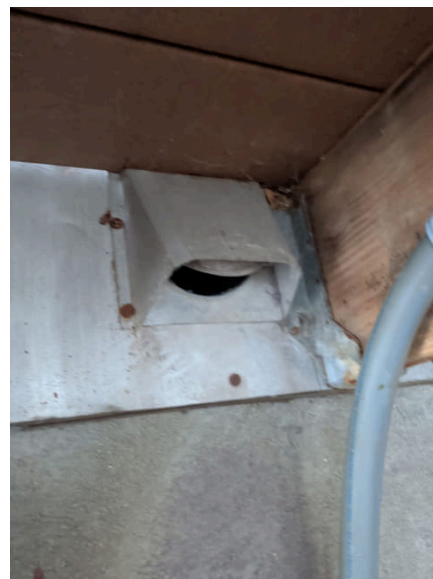
The **dryer exhaust vent** was observed beneath the **rear yard deck**, positioned on the right-hand lower side and oriented toward both the house and the street.

During the inspection no visible defects, damage, or blockage were identified at the vent termination. The vent appears properly installed, securely attached, and shows no signs of corrosion or deterioration.

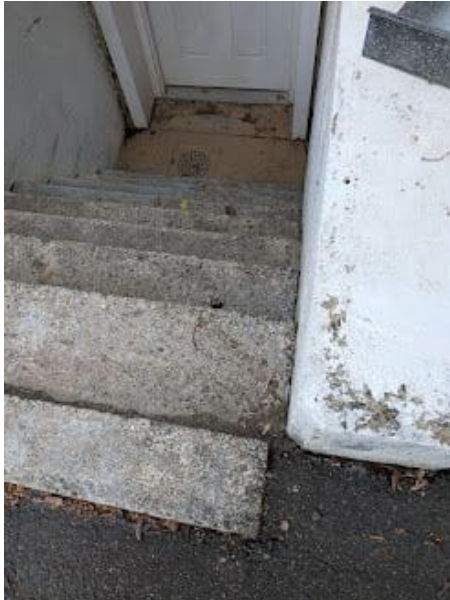
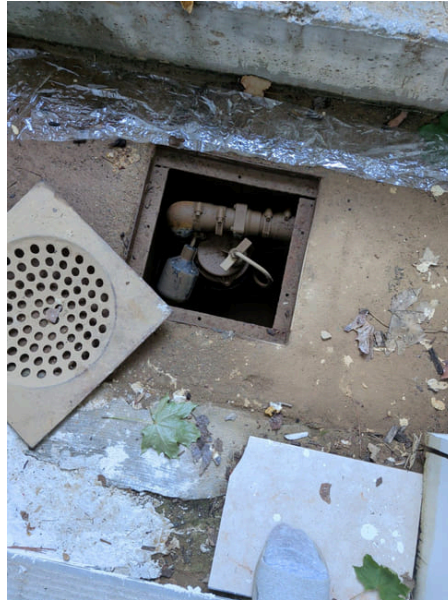
### 5.11.4 · Walk-outs Entry

The **basement exit sump pit** is noticeably small, limiting water storage capacity. The associated **sump pump** exhibits a sluggish water-level control response, which may delay pump activation during rising water conditions. This delayed response can increase the risk of water intrusion into the basement. It is recommended to replace the existing pump with a unit that features a more sensitive and rapid water-level control mechanism to ensure timely water removal.

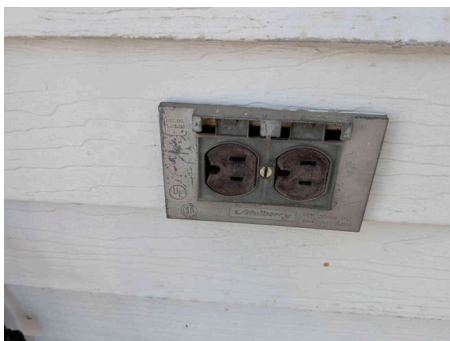
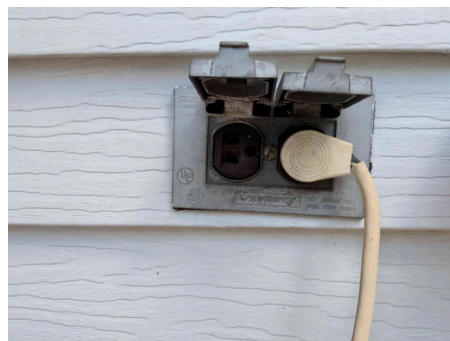
The existing exterior outlets are of an old model and, although they have waterproof covers, they lack GFCI protection. This condition presents a safety concern because the outlets are not protected against ground-fault currents in a wet environment.

It is recommended to replace all three outlets with code-compliant, outdoor-rated GFCI receptacles that include a weather-proof in-use cover to ensure proper protection.

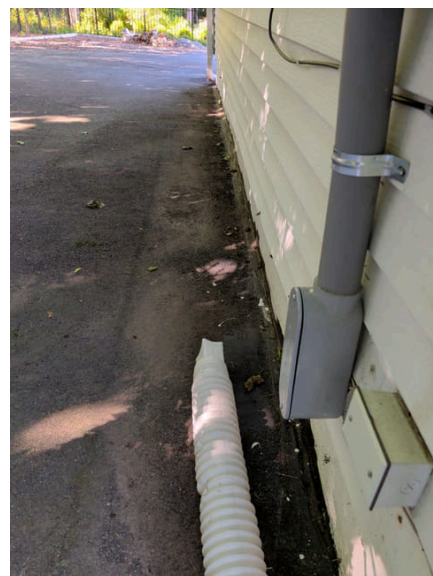
### 6.1.4 · Foundation

#### Foundation - Waterproofing Renovation (Right Side at Driveway Intersection)

The inspection observed that the homeowner has also completed a waterproofing and drainage renovation at the intersection where the right-side foundation wall meets the driveway. This modification is intended to prevent water infiltration at the joint, but the visual assessment could not verify the integrity of the waterproofing membrane or the effectiveness of the drainage slope.

**Recommendation:** Have a licensed waterproofing professional evaluate the work to ensure proper sealing, flashing, and drainage performance, thereby protecting the foundation from future moisture-related damage.

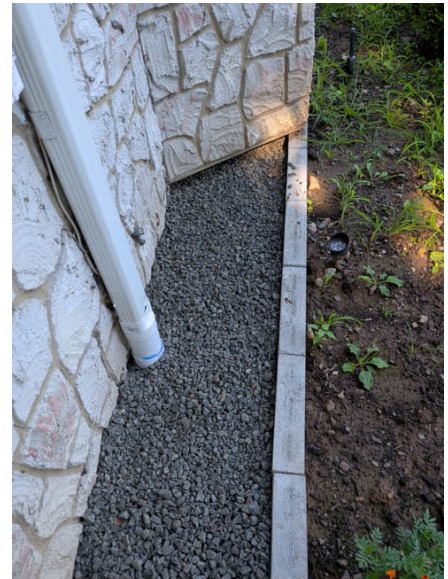
6.1.5 · Foundation

**Foundation - Waterproofing Renovation (Front Flower Bed)**

The inspection noted that the current homeowner had performed waterproofing and drainage renovations on the foundation wall adjacent to the front flower bed. The work appears to address moisture intrusion at the exterior wall.

Recommendation: Further monitor the drainage in these two areas. Also, monitor for water seepage in the corresponding parts of the basement.

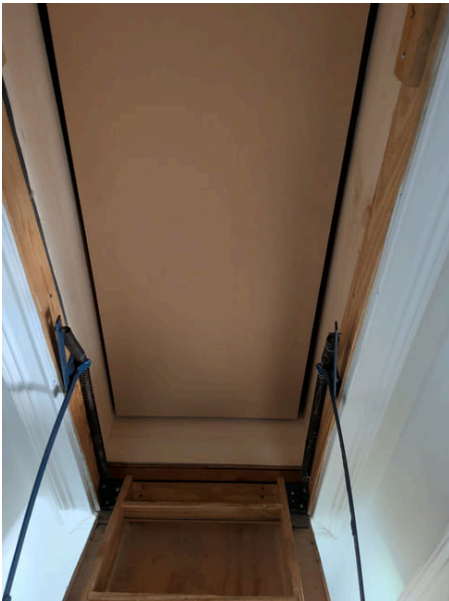
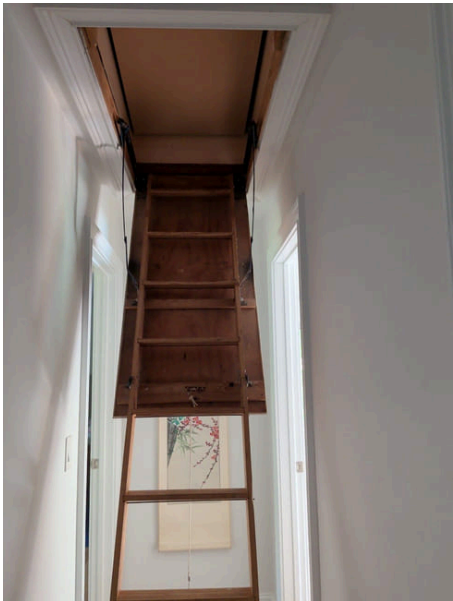
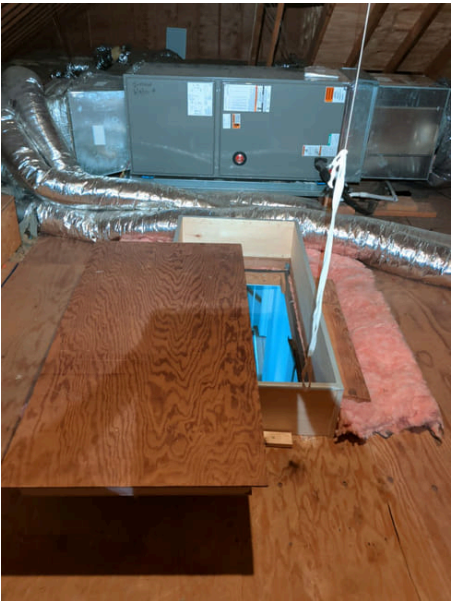
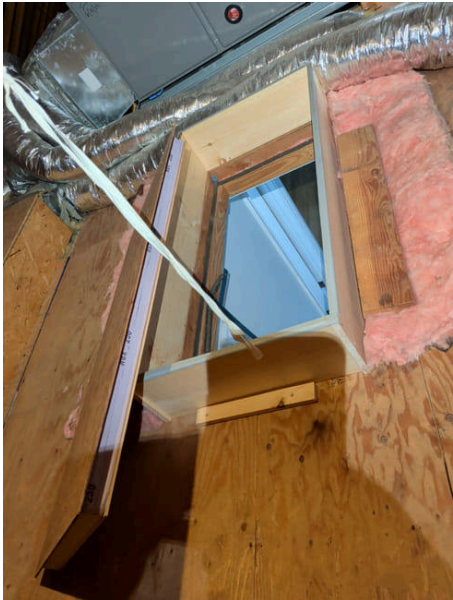
#### 7.1.6 · Insulation

The inspector observed that **rigid foam** insulation has been added at the attic entrance, which is a commendable improvement. This addition helps improve thermal performance and reduces energy loss.

Ensure that the foam is properly sealed around all penetrations and that fire-rated barriers are maintained where required. Verification by a qualified contractor is recommended to confirm compliance with local building codes.

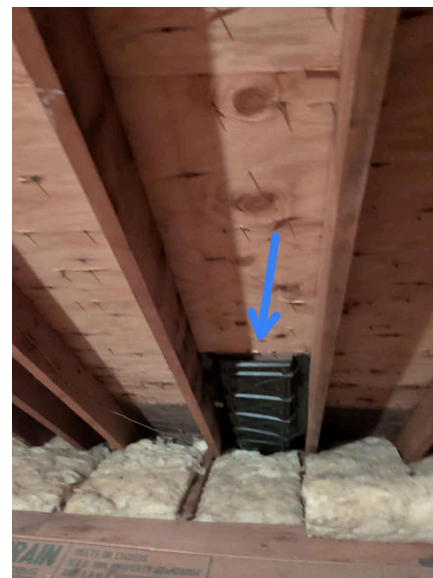
#### 7.1.7 · Insulation

The attic floor insulation has been modified with the addition of a baffle. This baffle is good for attic ventilation because it helps keep the soffit and ridge vent openings clear, allowing air to flow freely through the attic space. Maintaining unobstructed airflow supports the overall ventilation system, reduces the risk of moisture buildup, and can improve the efficiency of the home's heating and cooling equipment.

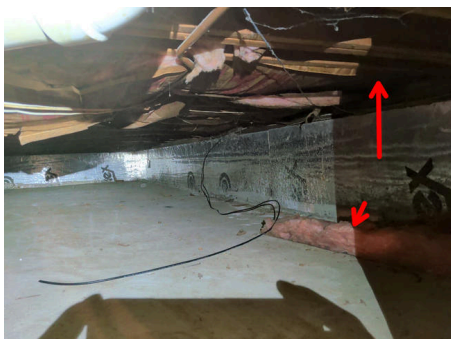
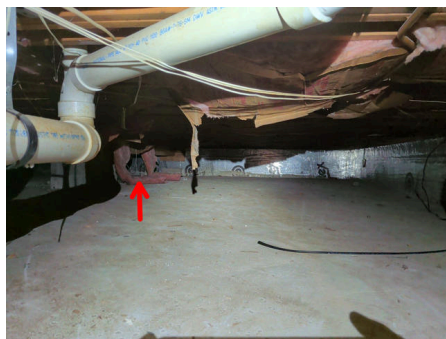
##### 📍 CRAWL SPACE

The insulation was displaced and/or missing in some areas of crawl space. Recommend repair as desired.

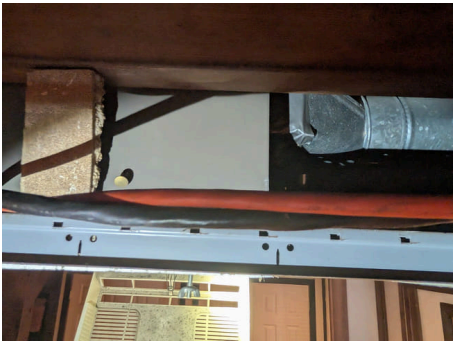
The existing ventilation fan in the basement has been removed, leaving the basement and crawlspace without adequate ventilation. This condition has resulted in elevated humidity levels, measured at more than 70% RH, which can promote mold growth and material degradation.

It is recommended to install a new exhaust fan or a dedicated fresh-air ventilation unit to provide continuous air exchange. Additionally, a dehumidifier should be installed to control moisture levels and protect the space from future humidity-related issues.

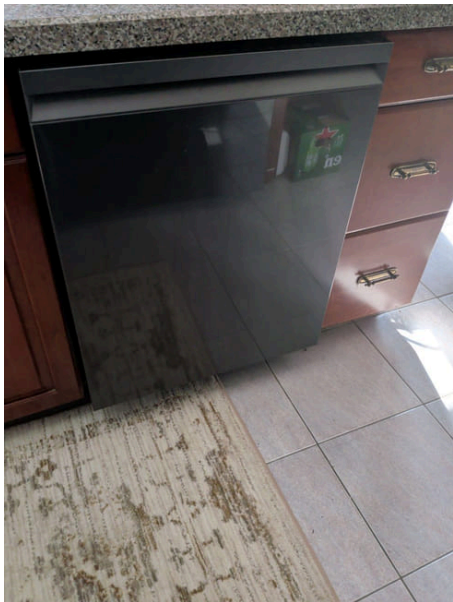
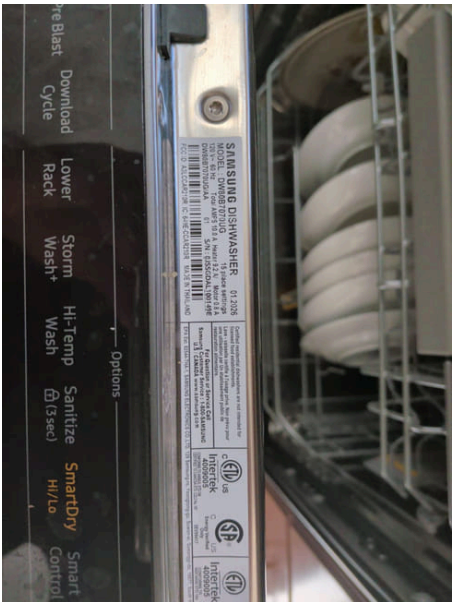
9.2.1 · Dishwasher(s)

The dishwasher was evaluated under a normal rinse cycle in accordance with NJ SOP and InterNACHI standards. The inspection covered physical integrity, door seal condition, water supply and drainage connections, and observation for any active leaks.

No visible leaks, seal failures, or drainage issues were detected during the test, indicating proper operation at the time of inspection.

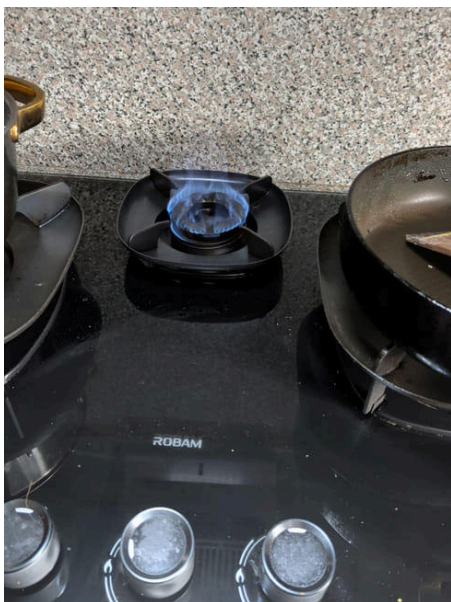
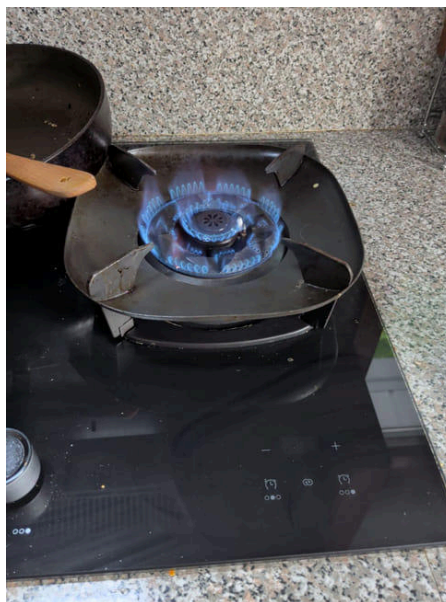
Based on NJ SOP and InterNACHI standards, the inspector performed a basic functional assessment of the kitchen **stove**, **oven**, and **cooktop**. The evaluation included verification of heating element response, oven temperature rise, control panel operation, and exhaust system performance.

Testing did not cover self-cleaning functions, timer accuracy, or probe precision. No deficiencies were observed during the functional checks.

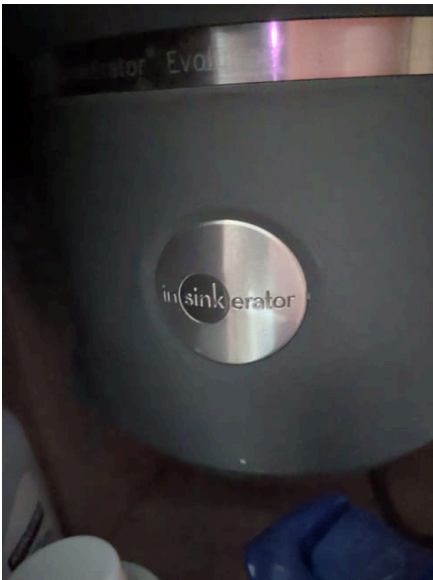
The **kitchen garbage disposal** was evaluated in accordance with NJ SOP and InterNACHI standards. The functional test included verification of the unit's **start response**, assessment of the **operating noise level**, inspection of the **motor mounting security**, and observation for any **visible leaks** while the unit was running. No deficiencies were observed; the disposal operates within acceptable parameters. Continue routine maintenance and periodic functional checks to ensure continued safe operation.

- ✓ Starts correctly
- ✓ Noise within acceptable limits
- ✓ Motor securely mounted
- ✓ No visible leaks during operation

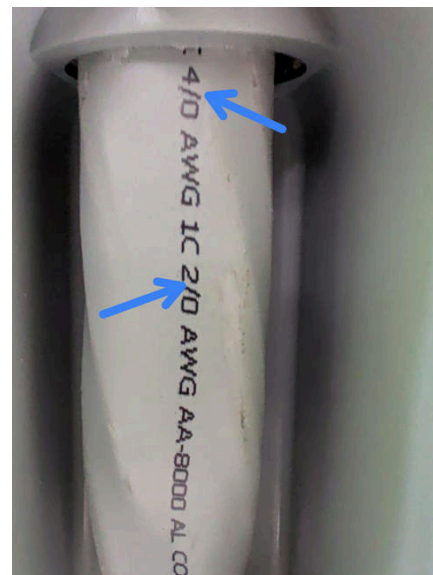
#### 10.1.3 · Service Entrance Conductors, Main Disconnect & Grounding

During the inspection of the **electrical service entrance**, the following service-entrance conductor sizes were observed: #4 AWG, #2 AWG, #1 AWG, 1/0 AWG, 2/0 AWG, 3/0 AWG, 4/0 AWG, and 250 kcmil.

These conductor sizes are consistent with the allowable ampacity requirements for the service load as defined by the applicable electrical code. No signs of damage, corrosion, or improper installation were noted on the conductors or associated terminations. The observed sizes provide a basis for confirming that the service is appropriately sized for the home's electrical demand.

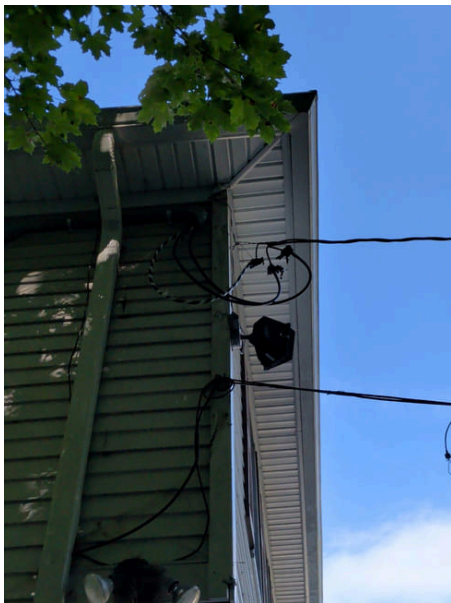
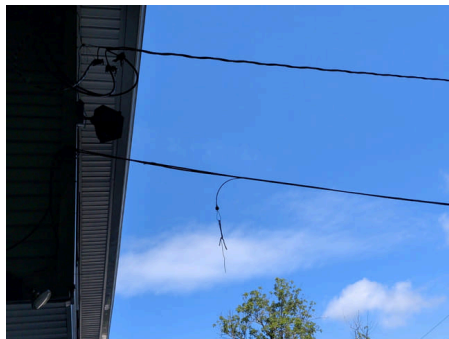
#### 10.1.4 · Service Entrance Conductors, Main Disconnect & Grounding

The electrical entrance cables enter the home from overhead. I recommend monitoring these cables and keeping branches trimmed away from wire locations to prevent damage.

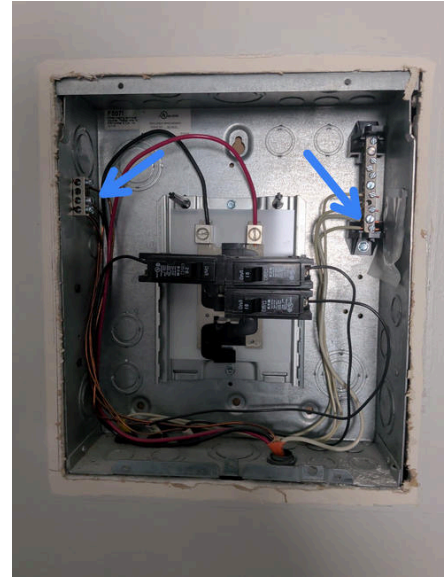
The **subpanel** was inspected and the **neutral conductor** was found to be physically separated from the **grounding conductor**. This configuration complies with the applicable safety standards for subpanel installations as required by InterNACHI guidelines and the National Electrical Code.

The separation prevents potential neutral-to-ground fault currents and enhances overall system safety.

No corrective action is required at this time.

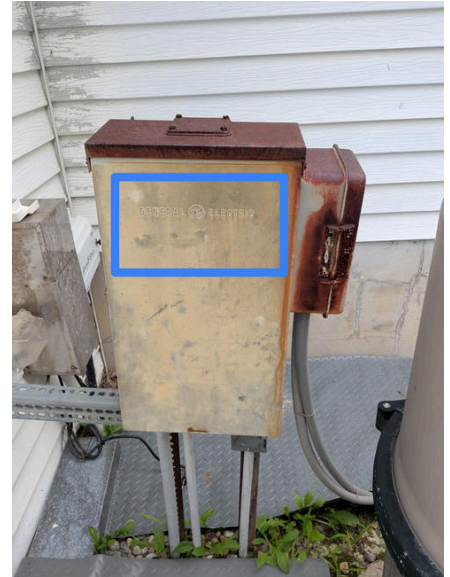
10.4.2 · Sub-panel-1 # 2

The **electrical sub panel** should have its manufacturer and rated amperage clearly documented. The panel brand (GE) and the ampere rating (30 A) are essential for evaluating system capacity and ensuring compliance with electrical codes. Verify that the nameplate or label on the panel is legible and record this information in the report.

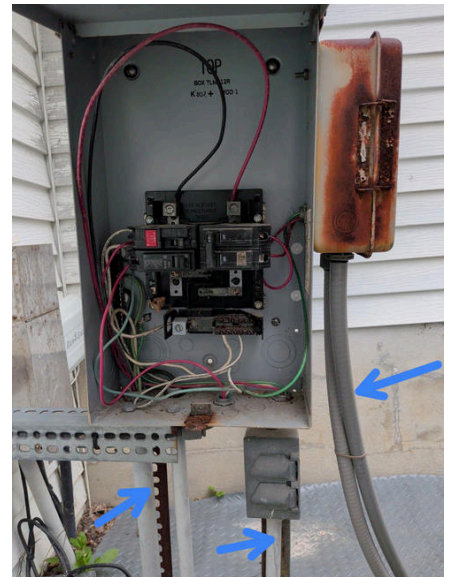
10.4.3 · Sub-panel-1 # 2

The primary electrical wiring method observed throughout the residence is **[NM-B (Romex) and conduit]**. All conductors identified are **copper**, which provides excellent conductivity and is consistent with standard residential construction practices.

No signs of damage, corrosion, or improper connections were noted on the exposed wiring. The observed installation appears to comply with the InterNACHI Home Inspection Standards of Practice and applicable electrical codes. It is recommended that the final wiring type be confirmed against the building plans and that any concealed sections be verified by a qualified electrician for proper protection.

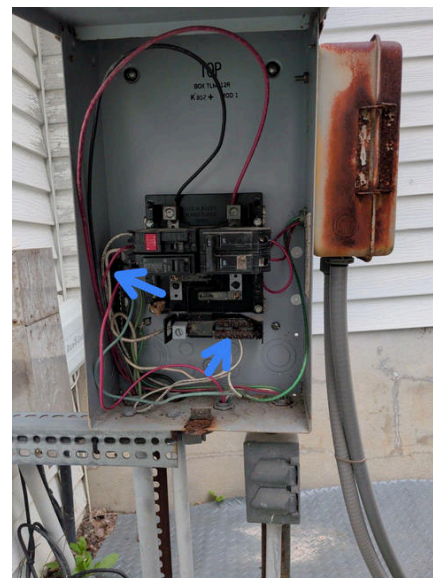
#### 10.4.4 · Sub-panel-1 # 2

The **subpanel** was inspected and the **neutral conductor** was found to be physically separated from the **grounding conductor**. This configuration complies with the applicable safety standards for subpanel installations as required by InterNACHI guidelines and the National Electrical Code.

The separation prevents potential neutral-to-ground fault currents and enhances overall system safety.

No corrective action is required at this time.

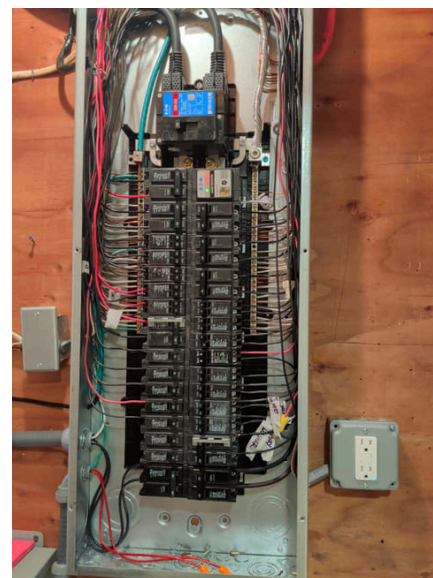
#### 10.5.1 · Over-Current Protection & Branch Circuit Wiring

**Branch circuit wiring** was inspected throughout the residence. The majority of the branch circuits are confirmed to be installed with **copper conductors**, which meet current code requirements for durability and conductivity.

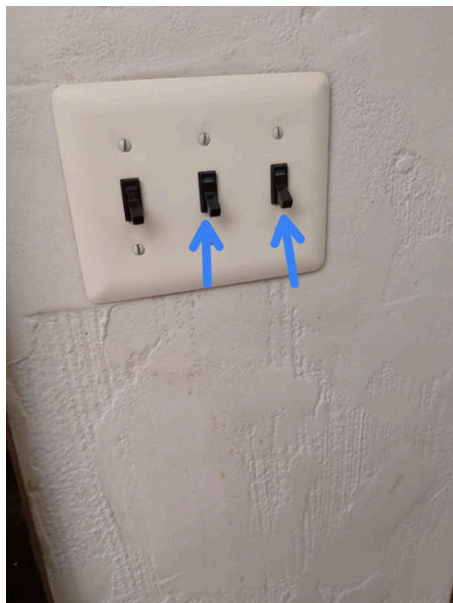
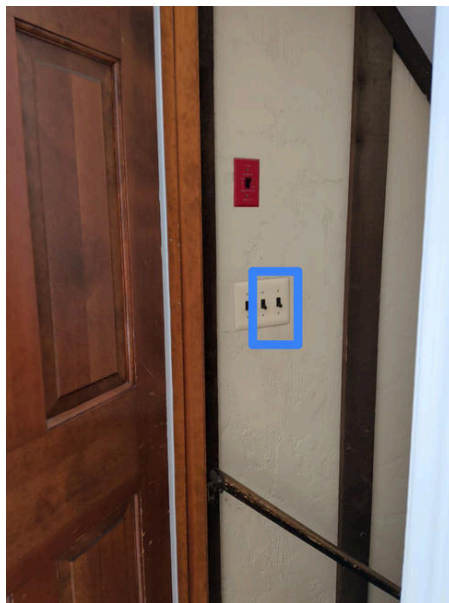
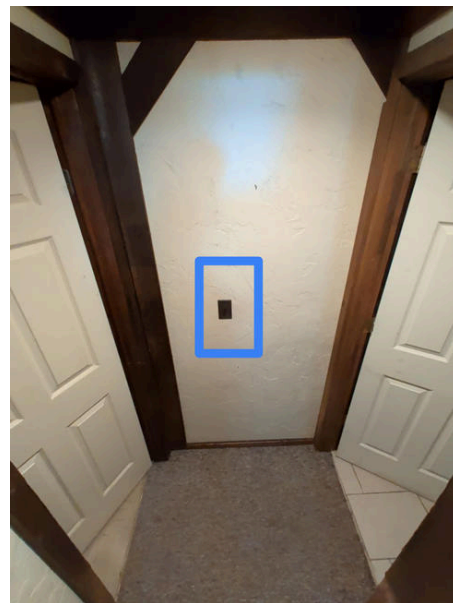
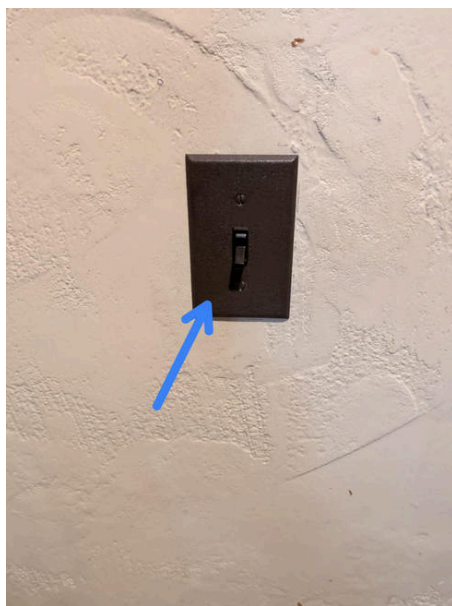
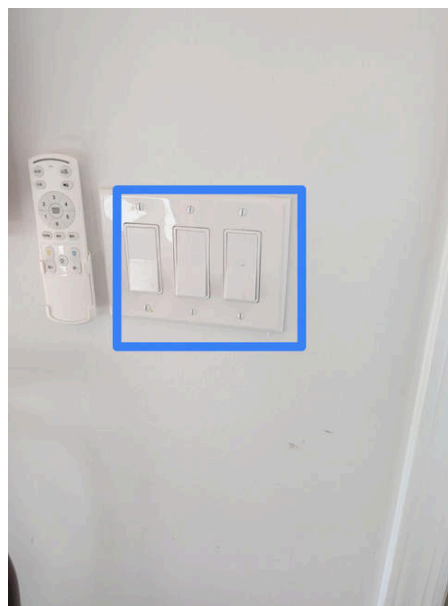
Some of the switches in the home did not appear to have function. Nearby receptacles that were accessible were checked. Recommend asking the current homeowner what they are for. Inoperable light fixtures will be noted

separately.

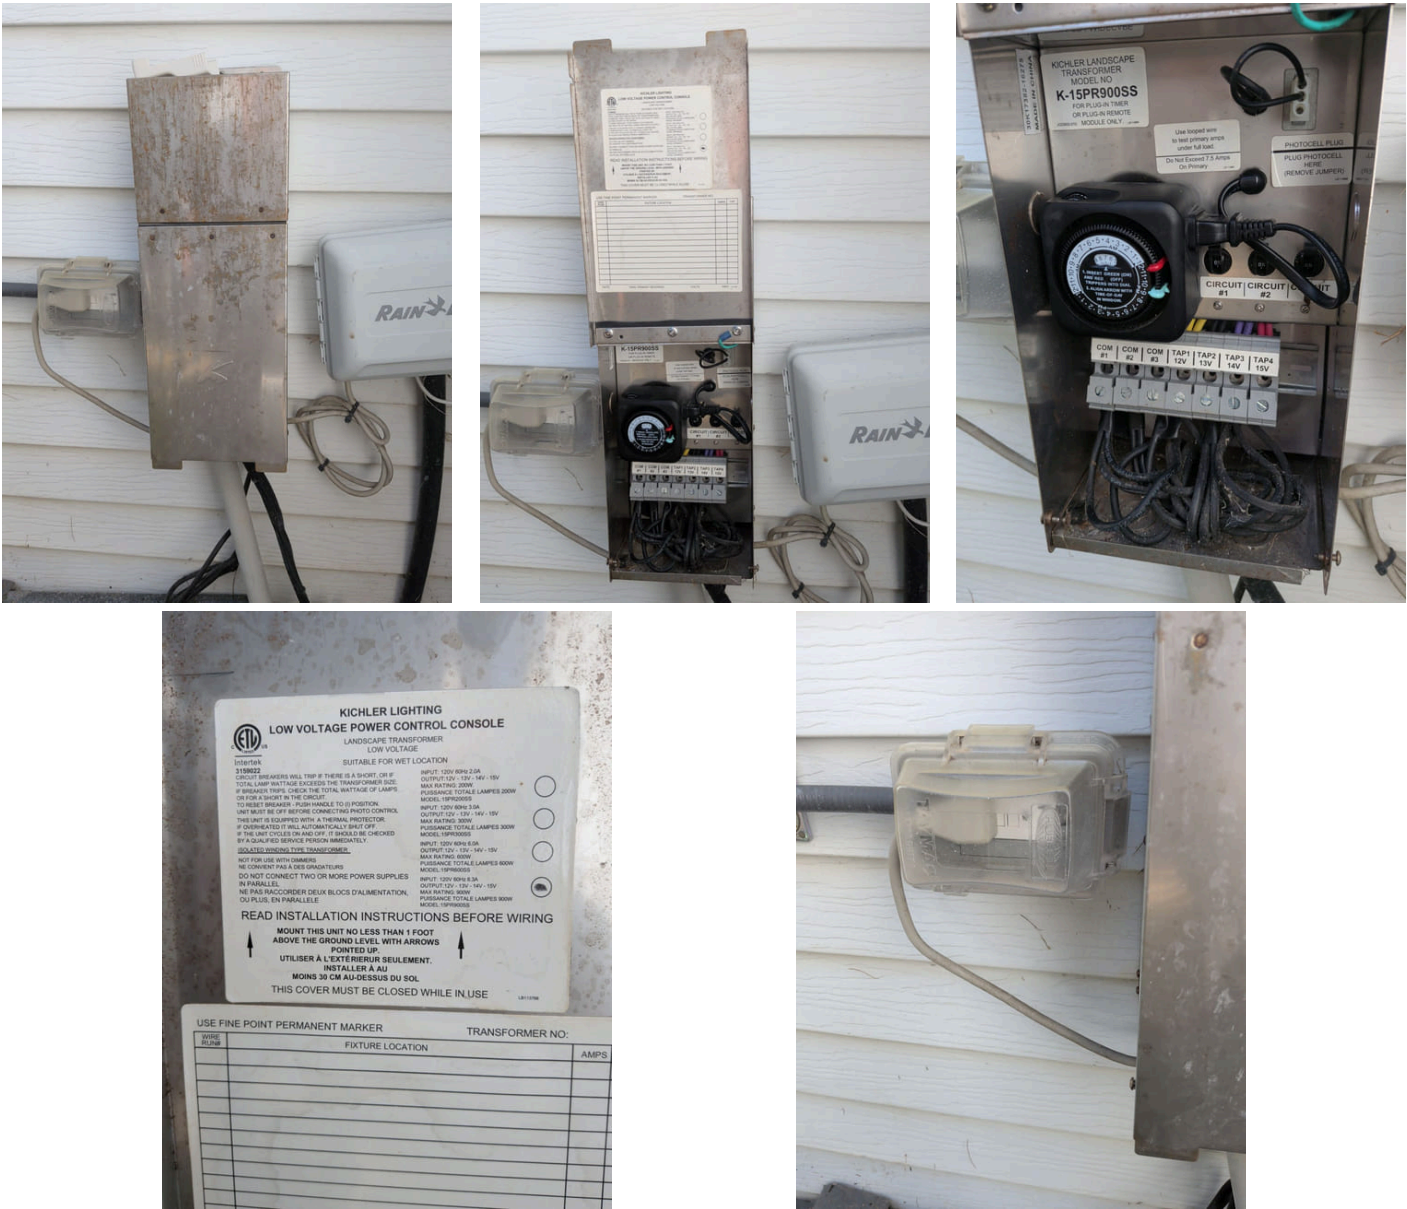
#### 10.7.1 • Outdoor Landscape Lighting Control System

**Exterior low-voltage landscape lighting system** was observed. The system is powered by a **dedicated transformer** and **timer**, providing illumination to the property's landscaping. All components appear to be installed in accordance with standard practices, and the system was operational at the time of the inspection. No visible damage or malfunctioning elements were noted.

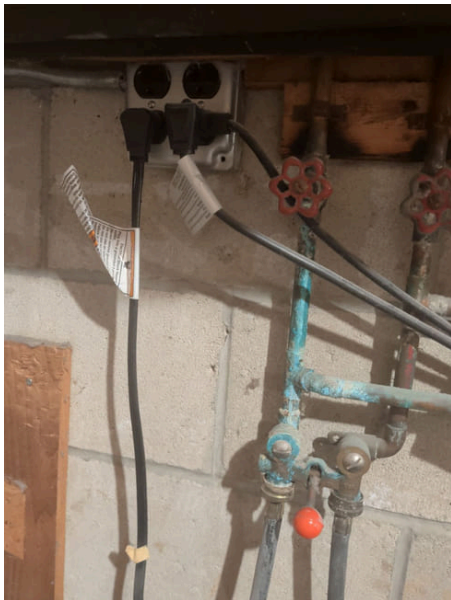
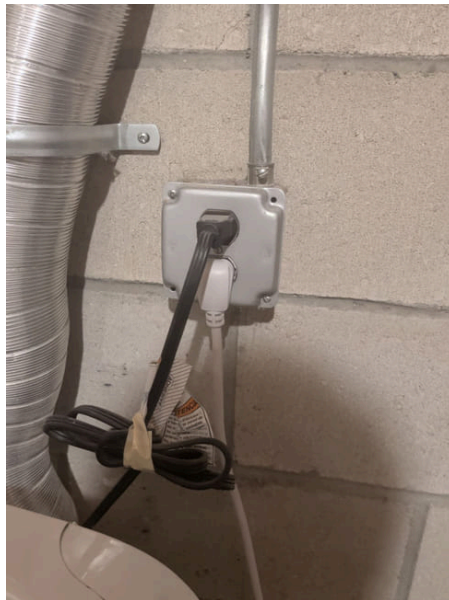
10.9.3 · GFCI & AFCI

The inspector verified whether each electrical receptacle in the inspected area is equipped with a **Ground Fault Circuit Interrupter (GFCI)** as required for safety in wet or damp locations. GFCI devices help prevent electric shock by interrupting power when a ground-fault current is detected.  
Any receptacle lacking GFCI protection should be upgraded to meet code requirements.

✔ Not GFCI Protected

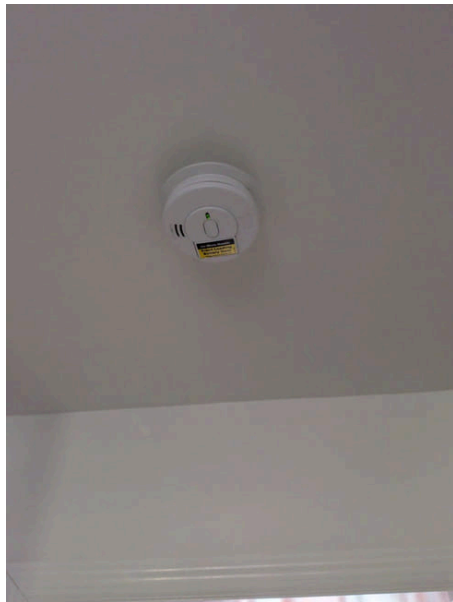
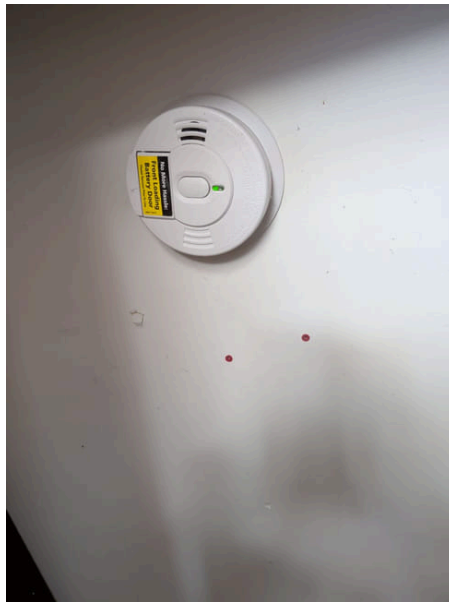
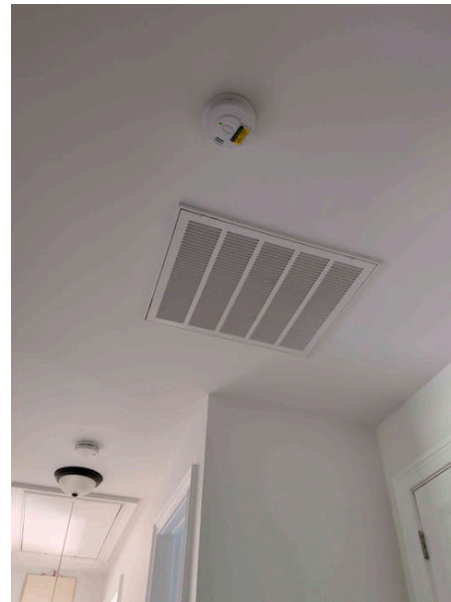
#### 10.12.1 · Smoke Detectors

All smoke detectors were tested and operational at the time of the inspection. Any discrepancies will be noted in the observation section of this report.

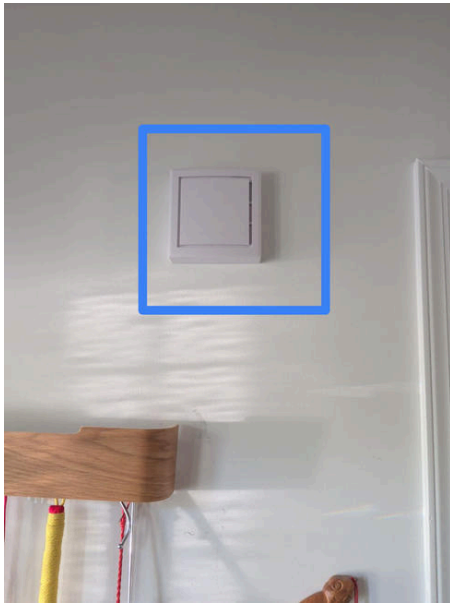
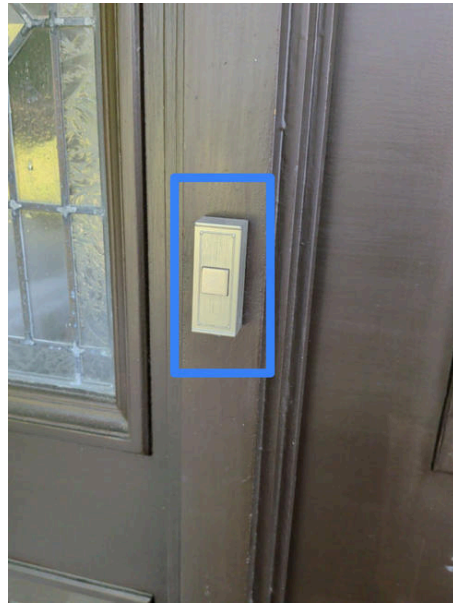
### Door Bell - Inside

Due to the addition, the door bell was located indoors. It was functional. Relocate as desired.

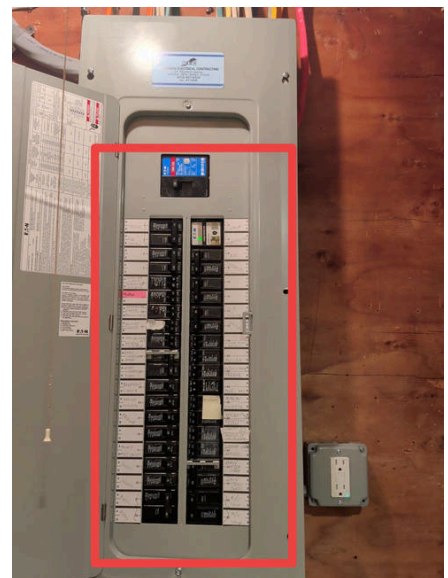
#### Electrical Panel - Missing Circuit Directory

*The main electrical service panel lacks a clear circuit directory or the existing labeling is illegible, making it difficult to identify breaker functions. According to the NEC and InterNACHI standards, each circuit breaker must be accurately marked with its intended load.*

*This deficiency can impede safe operation and troubleshooting during emergencies.*

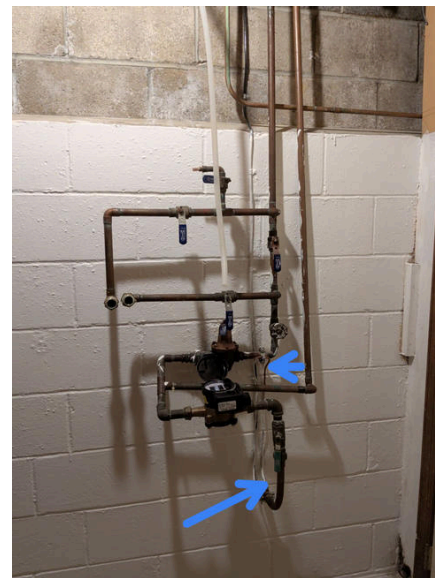
11.1.6 · Water Supply & Distribution Systems

The **water distribution system** was inspected for functional flow, material integrity, and safety throughout the residence. Observations include **excessive water pressure** and the **absence of required electrical bonding** of metallic piping, both of which can lead to pipe damage or electrical hazards.

It is recommended that a New Jersey Licensed Master Plumber evaluate the system, adjust pressure to code-acceptable levels, and install proper bonding in accordance with local plumbing codes.

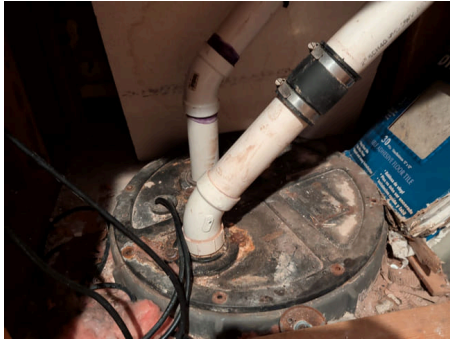
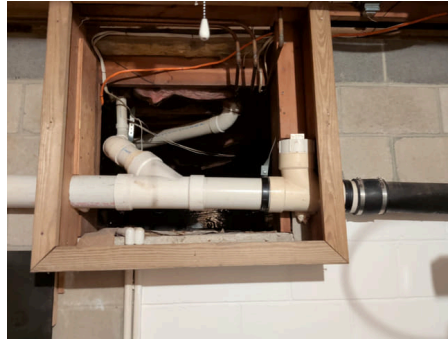
## PVC Vent Stacks

PVC was used for the plumbing vent stacks. PVC is not UV resistant and will get brittle with time. Although not required, it is recommended to paint PVC to protect it from the damaging effects of the sun.

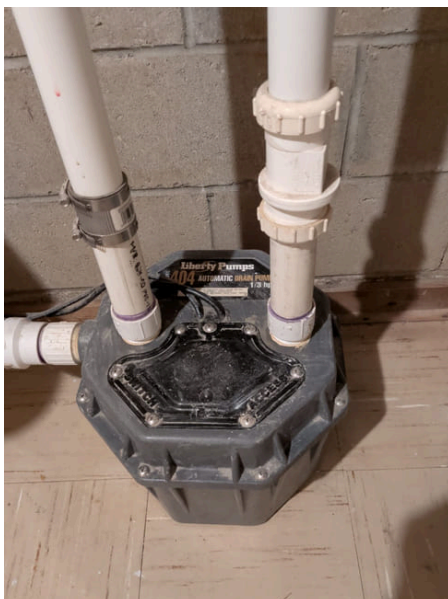
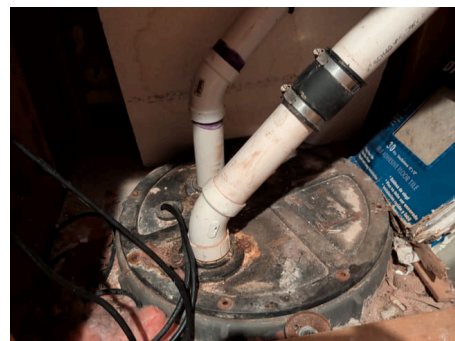
## Sewage Ejector Pump - Installed in Basement

A **sewage ejector pump** is installed in the **basement** to convey low-lying wastewater to the main sewer line. The system appears to be correctly positioned and connected. During the inspection no visible leaks or abnormal noises were observed.

It is recommended to perform regular functional testing and maintenance in accordance with the manufacturer's instructions to ensure reliable operation.

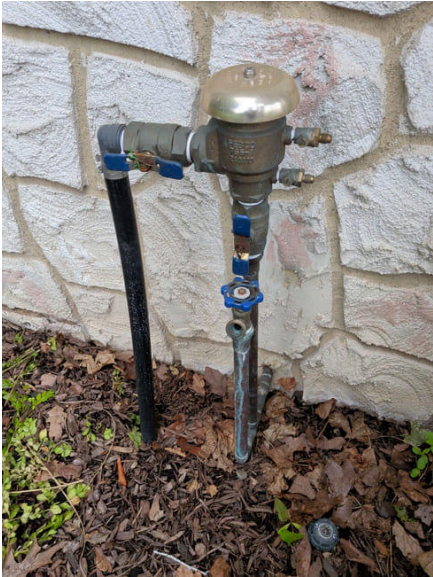
The inspector evaluated the water supply system for the presence of a **vacuum breaker** or **backflow preventer**. These protective devices are required to prevent contaminated water from back-flowing into the domestic drinking water system. No such device was observed at the water service entry point.

Installation of a code-compliant vacuum breaker or backflow preventer is recommended to ensure the safety of the potable water supply and to meet local plumbing codes.

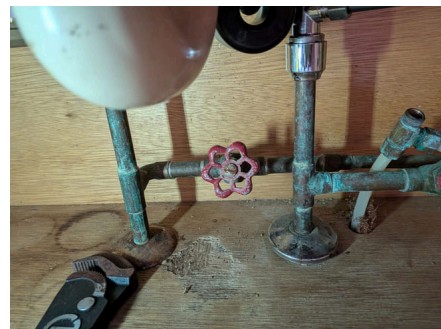
Corrosion - Pipes / Valves

The water distribution pipes and/or valves showed signs of corrosion in the noted locations; not actively leaking. Recommend monitoring and repairing as needed.

Note: Being proactive with repairs is suggested to prevent moisture issues.

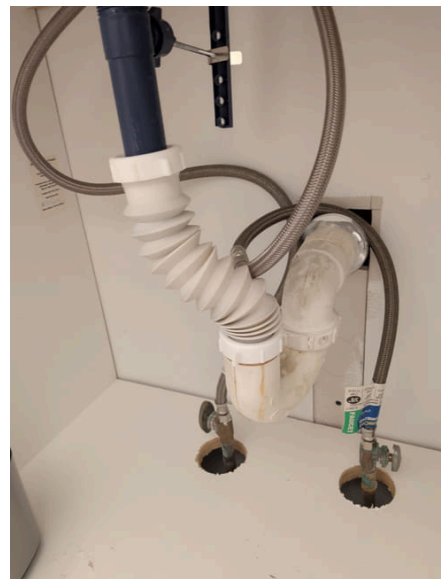
OFFICE AREA BATHROOM

Drain Pipe - Improper

The discharge pipe was not properly installed. Recommend repair by a qualified plumber.

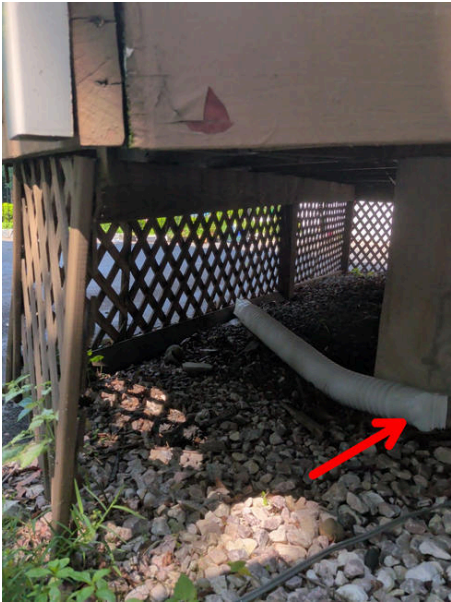
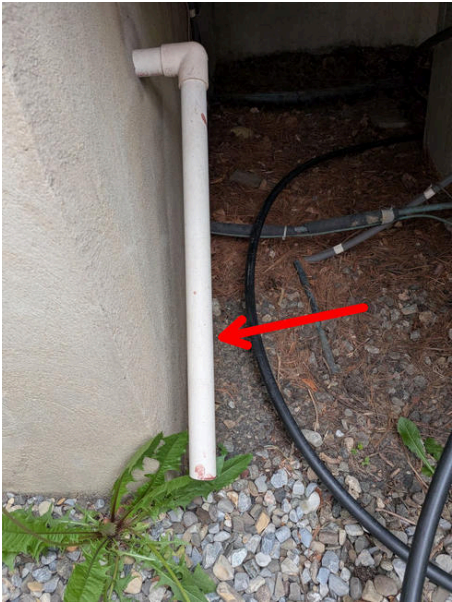
📍 BASEMENT

Sump Pump - Drains Near Foundation

The sump pump drain lines drained near the foundation. Recommend directing the water away from the home's foundation.

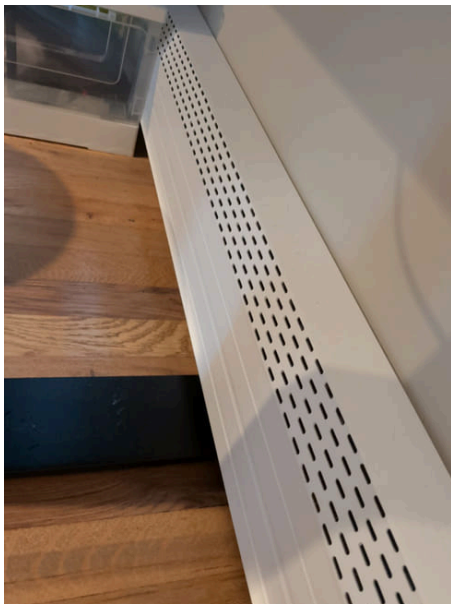
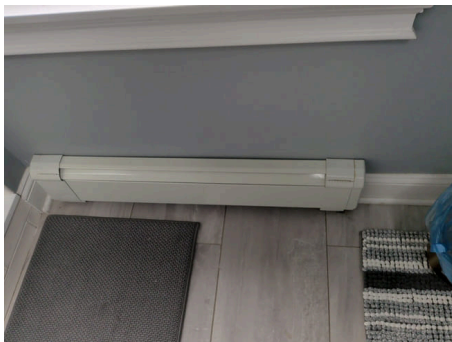
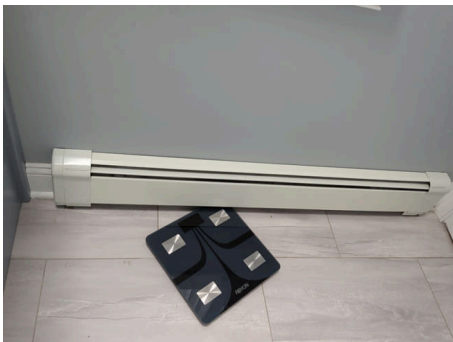
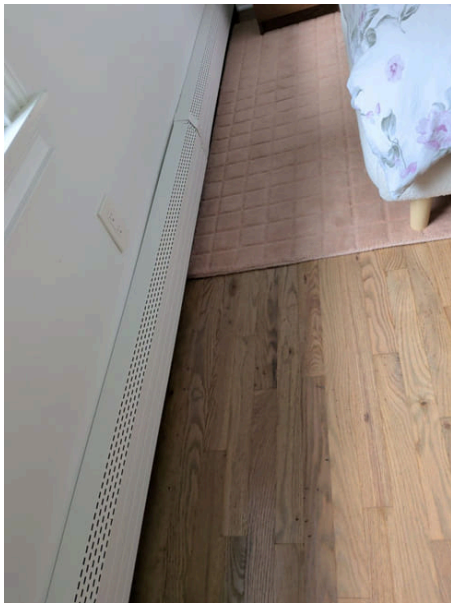
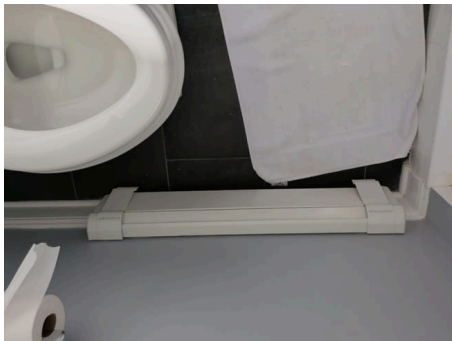
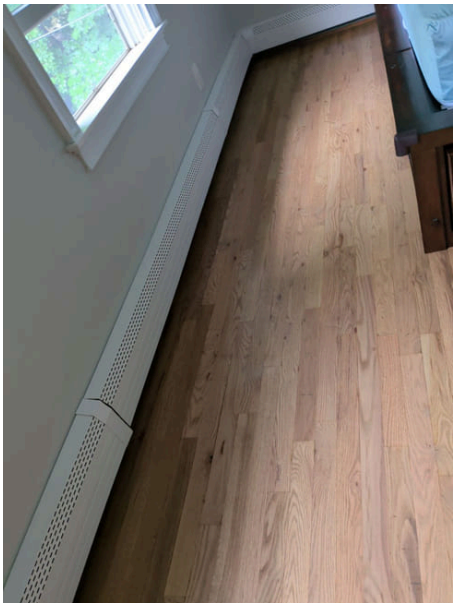
Radiant Heating System - Tested

The radiant heating system was tested for proper function and heating ability.

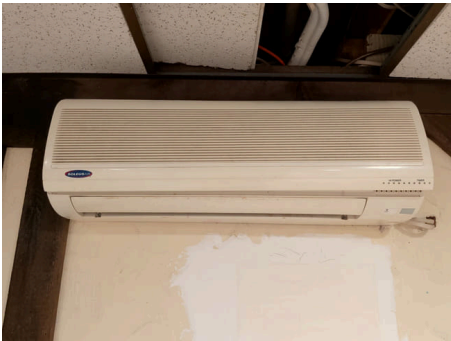
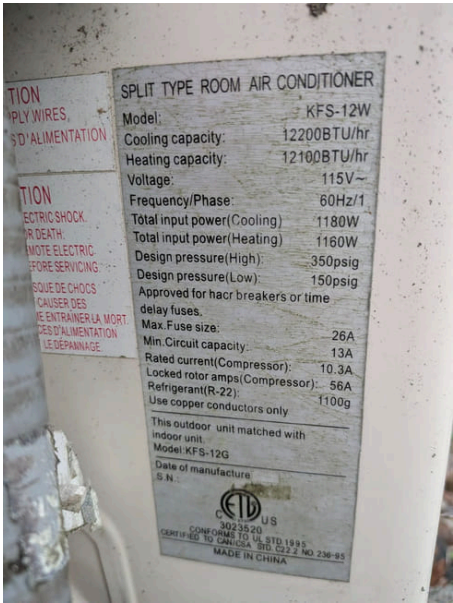
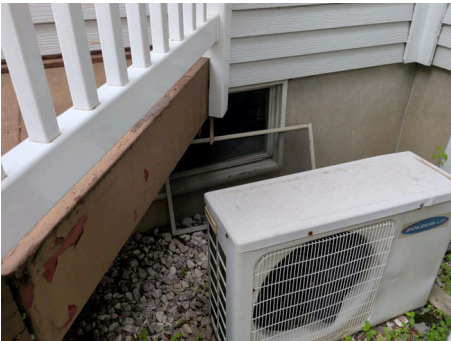
13.5.2 · Ductless Split System

Ductless Split System - Unit Age

📍 Basement

The mini-split ductless air conditioner located in the Basement has been in service for nearly 40 years. This extended service life is notable and should be documented for future reference.

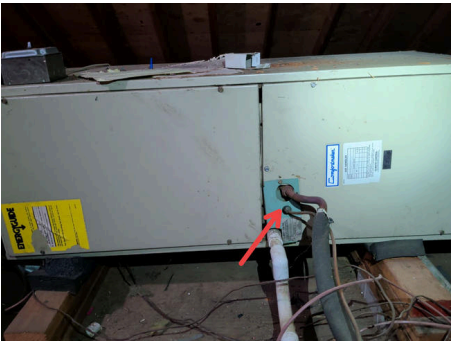
Central Air Conditioning - Condition

The central air conditioning system in the Office Area has been in service for approximately 40 years, exceeding its designed lifespan. The refrigerant does not meet current standards. Although the unit still operates, the

indicate reduced efficiency. It is recommended to replace the system with a new, code-compliant unit to improve performance and reduce energy costs.

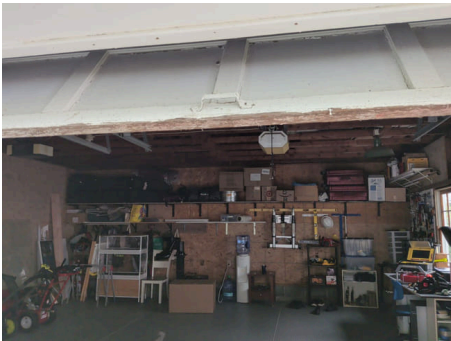
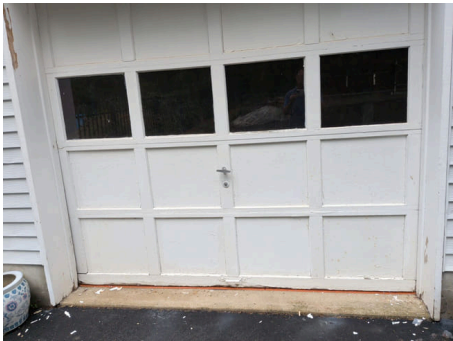
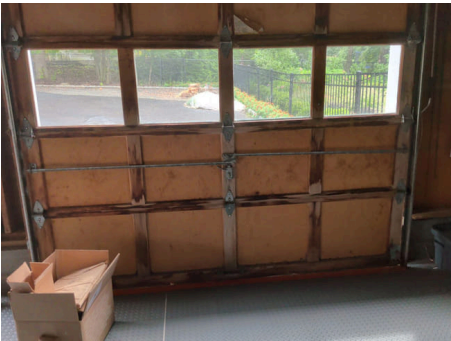
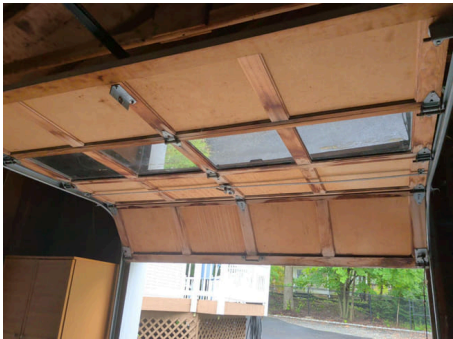
15.7.1 · Vehicle Door(s)

Door - Outdated

The overhead garage door was older and outdated. It did not have a lot of the safety features that are required on newer garage doors. Although not required, I recommend replacing for safety purposes.

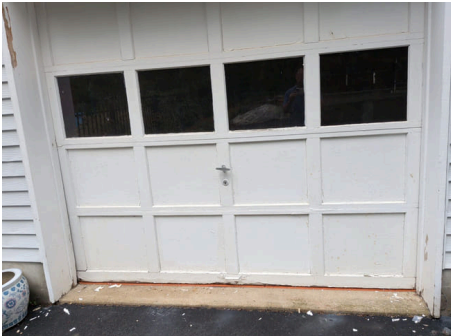
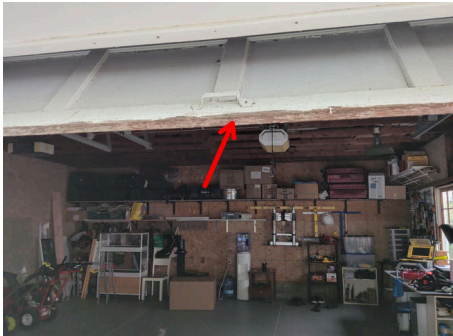
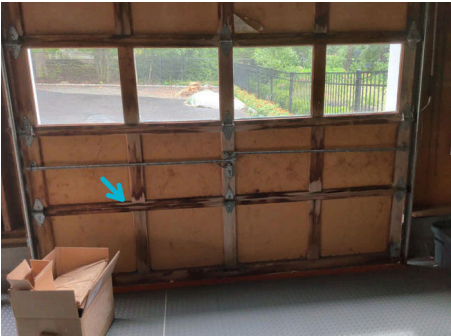
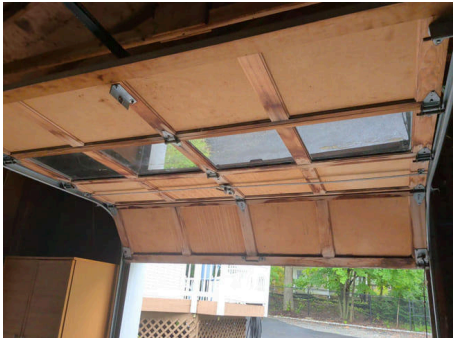
The garage door is very **old** and shows signs of wear consistent with its age. While it remains functional, the advanced age increases the likelihood of future failure and may affect energy efficiency. It is recommended to plan for a replacement at an appropriate time to maintain safety, curb appeal, and reliable operation.

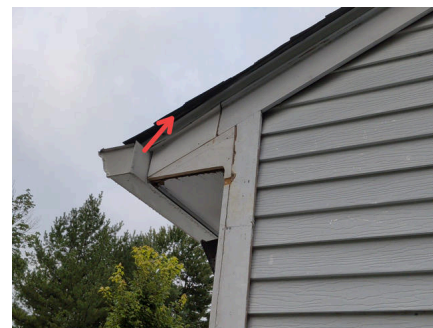
### Asphalt Roof - Multiple Layers

The asphalt/fiberglass composition roof seemed to have multiple layers of shingles. It's important to note that additional layers of composition shingles often have a reduced lifespan, typically around 80% of their rated durability, and this may void the manufacturer's warranty. When the time comes to replace this roof, it's essential to be aware that all existing layers will need to be removed. This is an FYI item.
