**GRAND VIEW**  
Property Services

## RESIDENTIAL INSPECTION

**August 25, 2026**

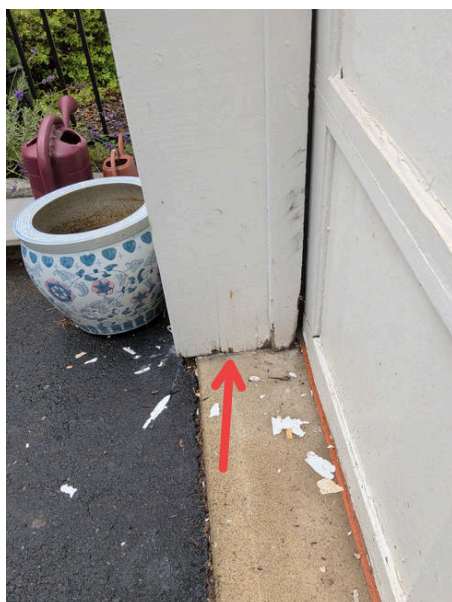
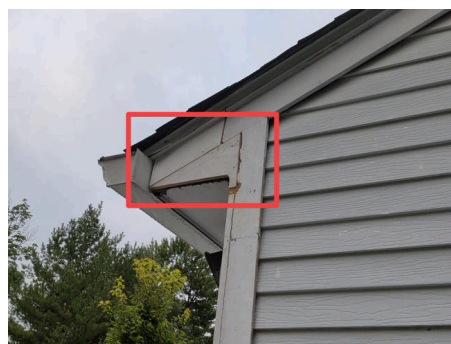
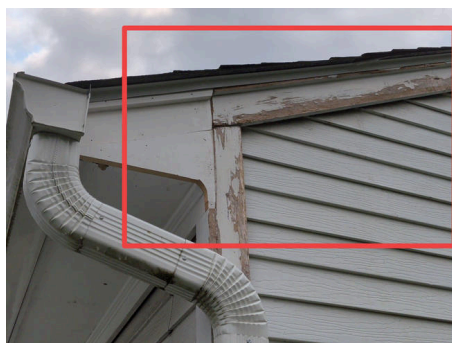
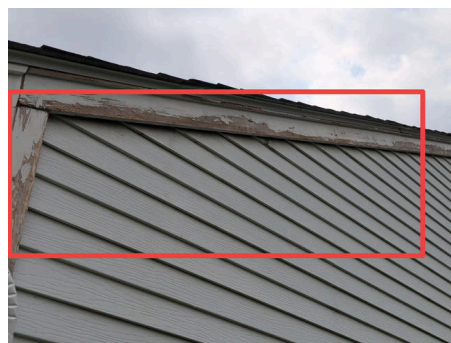
📍 GARAGE

Peeling paint was observed at the time of inspection. Recommend repair as desired.

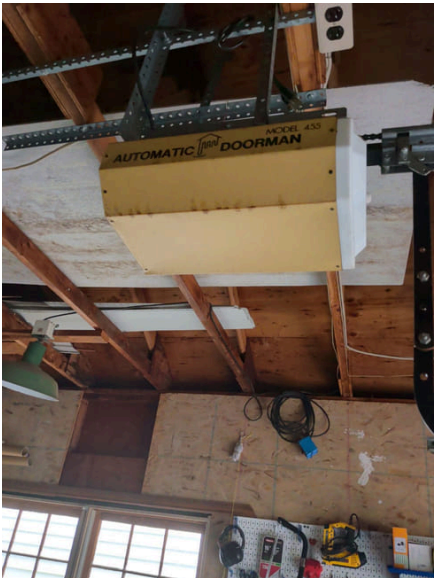
15.8.3 · Garage Door Opener(s)

Garage Door Opener - Non-functional

The right-side garage door opener is non-functional. It does not operate when the remote or wall switch is used, rendering the door inoperable. This condition poses a risk of being trapped in the garage and prevents safe egress. Replacement of the opener is recommended to restore proper function and ensure safety.

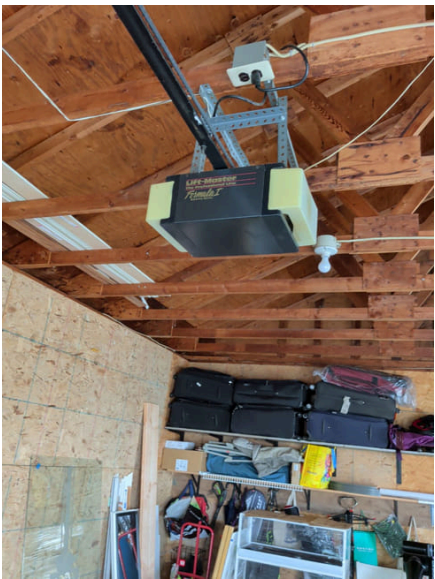
The left-side garage door opener is barely functional and is not sensitive to the pressure test or obstacle-rebound test. The opener fails to reverse when a slight pressure is applied, indicating a loss of the safety reverse feature. Because this deficiency compromises the safety mechanism, replacement of the opener (and the right-side unit) is recommended.

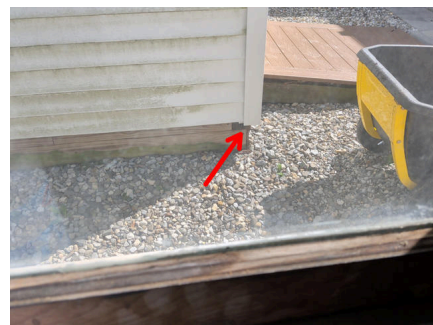
16.4.1 · Foundation & Structure

### Wooden Shed Base - Rot, Termite, Settlement Check

The **base of the wooden shed** located directly on the ground was inspected for signs of deterioration. **Rotting wood**, evidence of **termite activity**, and any **significant settlement** of the foundation were evaluated. No visible decay, insect damage, or uneven sinking was observed at the time of inspection. Continued monitoring is advised, especially in moisture-prone areas, to ensure the structural integrity of the shed remains sound.

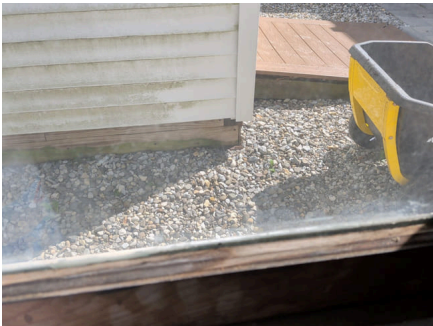
The shed’s shady side was observed to have extensive moss growth covering the exterior surface.

While this does not presently affect structural integrity, moss can retain moisture and eventually lead to wood rot if left unchecked. It is recommended to clean the affected area using a mild cleaning agent and a soft brush, ensuring thorough removal of the moss. Periodic maintenance should be performed to prevent re-accumulation.

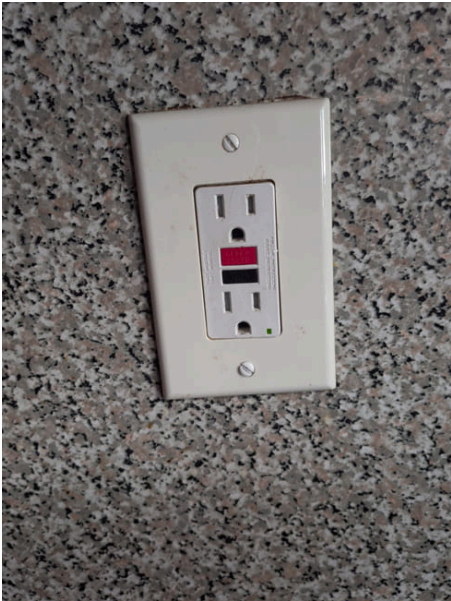
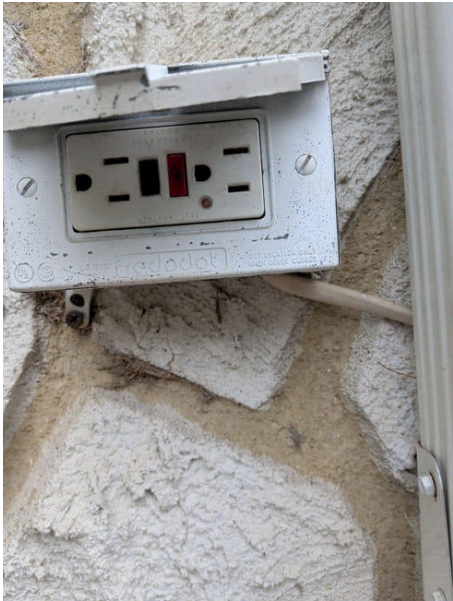
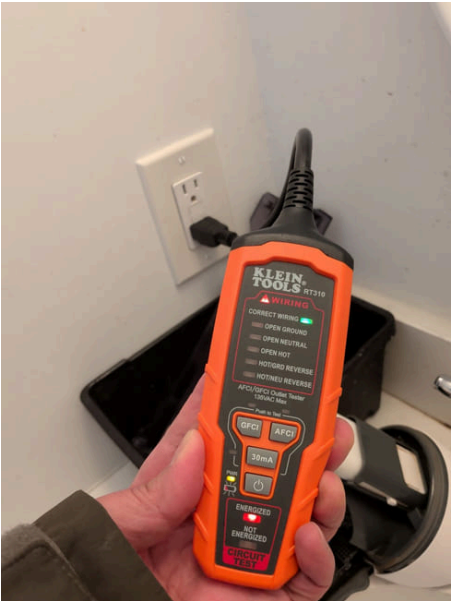
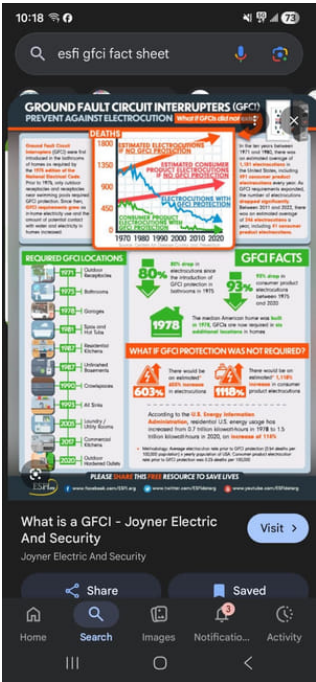
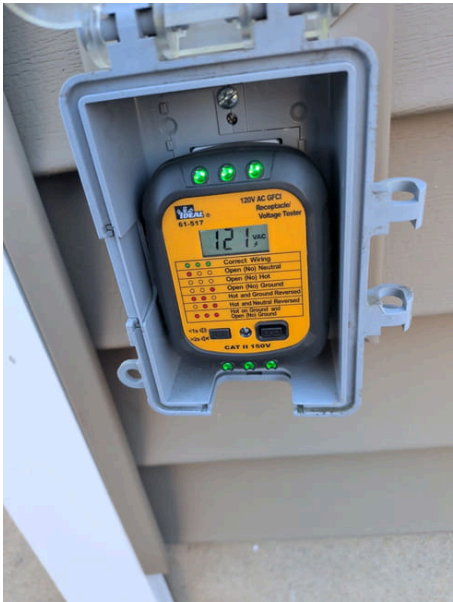
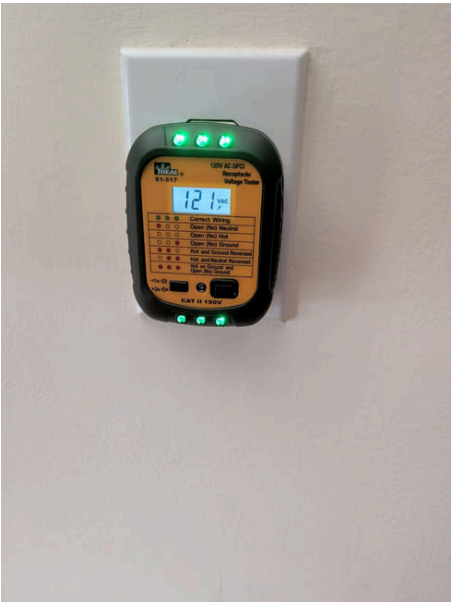
After completing inspection and functional testing, all ground-fault circuit interrupter (GFCI) receptacles and associated circuit breakers were verified to be operating correctly and have been safely reset to ensure continued protection against ground faults.

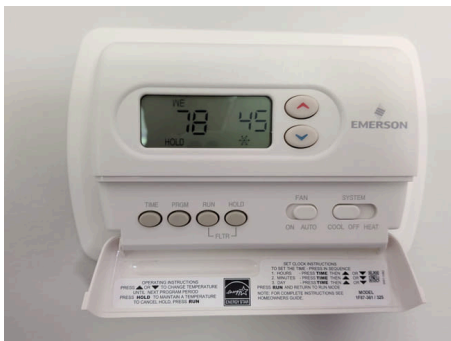
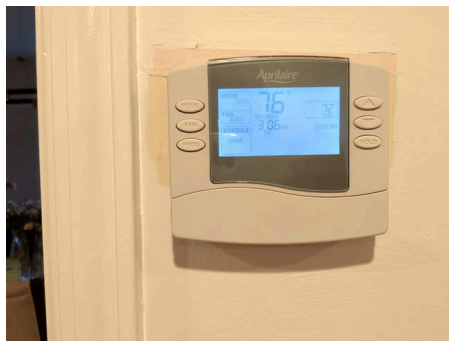
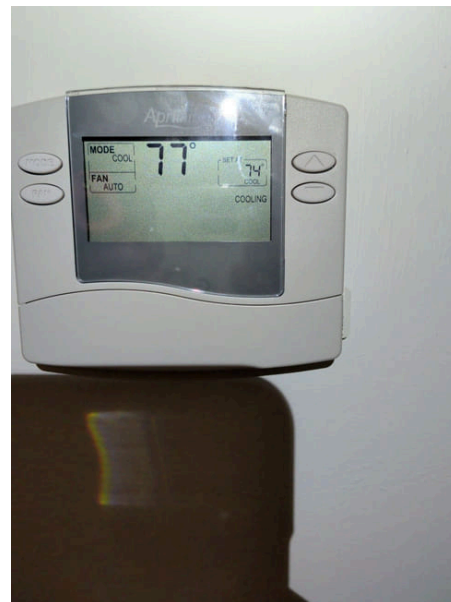
17.3.1 · Thermostat Setting To Its Pre-inspection State.

The thermostat was returned to its pre-inspection setting; the mode was **OFF** and the temperature display read **74 °F** as shown in the accompanying photograph.

No adjustments were made during testing, and the system remained in this condition at the conclusion of the inspection.
